## COCKERMOUTH RECOVERY FAILURES and Deja vu 2009

Three weeks after the town of Cockermouth was flooded I undertook this audit of flood restoration progress. I had intended to spend a couple of days reviewing the progress in restoration competence since the floods of Hull, Doncaster, and Sheffield of 2007 where homes took months to years to restore. In less than two hours I realised there was no improvement from my inspections of 2007 or indeed my flood audits of Carlisle 2005 and even going back to Lewes in 2000.

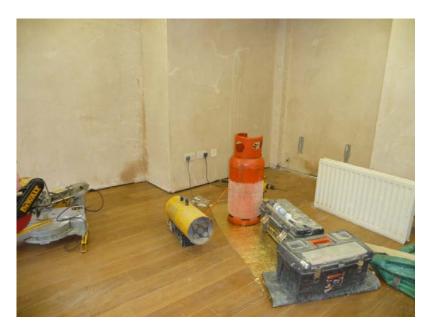
**Photo 1** Ready to move in after only three weeks?

While there are minor technical issues about this job, the reality is that this shop is almost ready for business because the builder used common sense instead of "we always do it this way"

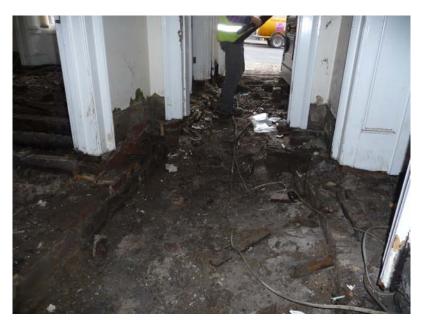
Photo 2 Getting ready to strip the walls?

This builder has removed the floor because it got wet. The walls are next to be stripped as he did in photo 3. If wood is so moisture sensitive why did they build boats from it? Photos 1 & 2 are reminiscent of the Carlisle audit " see www. Claimtech.co.uk (Flood victim support) See photo 8 too.

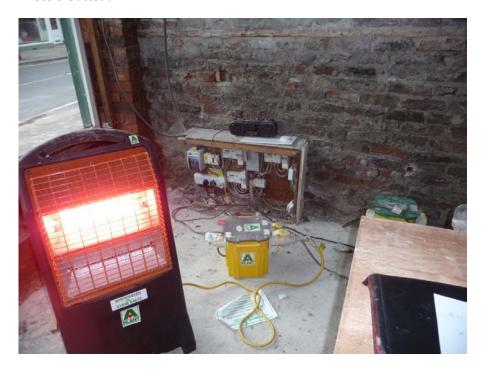
# Photo 3 Gutted?

**Technical point.** This Infra red heater does nothing to heat the atmosphere as it is radiant not convective heat. A waste of time and money for insurers.

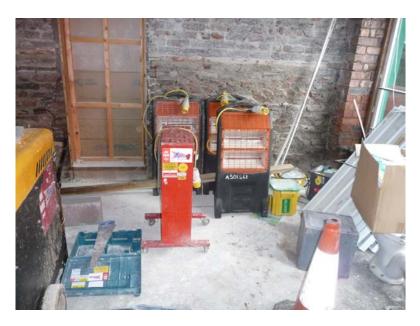
Photo 4 Waste of resources

Despite the electricity being on as seen in photo 3 this drying equipment is not connected or turned on. A waste of money paid for insurers and delaying recovery.

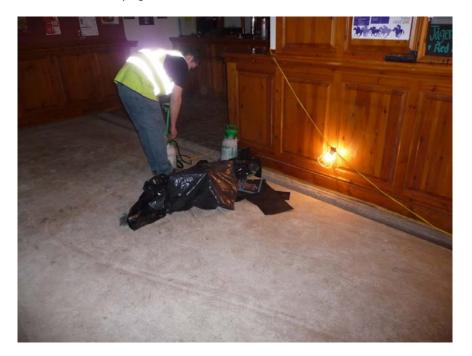
Photo 5 In situ drying

This pub was dried by the Revival Company in a few days. There are sanitation and perhaps some residual issues but this must be seen as a move forward

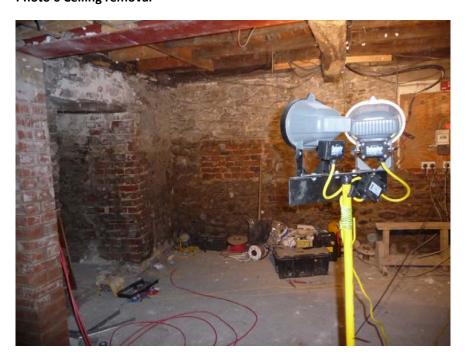
**Photo 6 Ceiling removal**

This building company decided to remove the ceiling although the water level can be seen and recent temperatures were unlikely to have resulted in high humidity or the need to remove it?

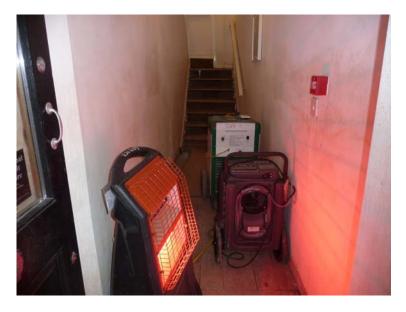
Technically the open door would have made good sense as the radiant heat would encourage humidity to move to the outside, the unfortunate evidence is that the green dehumidifier plug sits on top of the machine and the drain pipe of the red machine is still coiled around the machine. Waste of equipment and money.

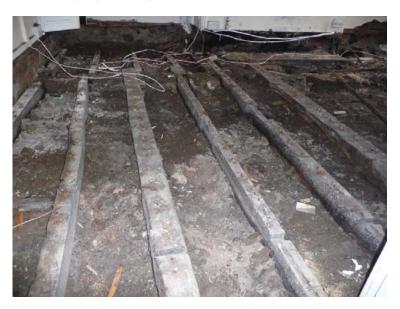
# Photo 8 Improper salvage

The floor boards have been removed and the joists are left. These wood joists are embedded into the wet earth and will take a long time to dry. Should they have been removed too?

This is a technical question that would require investigation but the decision making process should be explained by review.

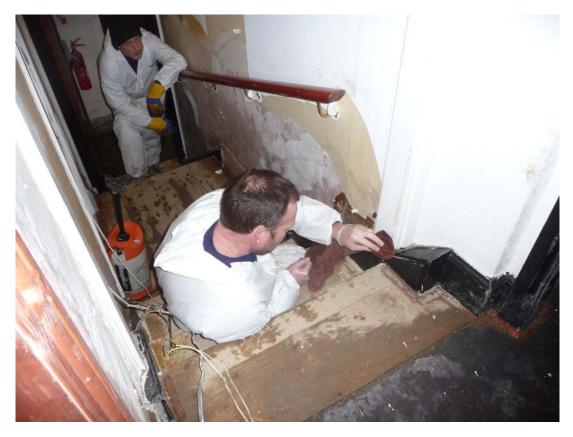
The pump up pot is for spraying a sanitising chemical onto the wall and is useless because if it was any good the man spraying it would be wearing, rubber not cloth gloves, a respirator and goggles, equally he wouldn't be doing it over the head of his technician colleague who is wiping down the black paintwork with a towel. This detailed decontamination is perhaps a little premature as the whole pub and basement has yet to be dried and restored. Perhaps the whole pub and basement should have been steam cleaned?

Possibly a waste of time and money?

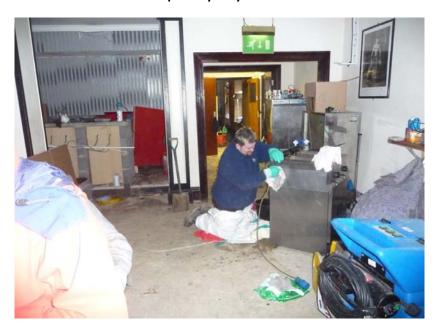
Photo 10 Sanitation of deep fat fryer by ISS

ISS are one of the largest restoration companies in Europe. Here we see their technicians restoring a gas stove and 240 volt deep fat fryer. As these items were submerged in black water they obviously require this very detailed decontamination and salvage. Decontamination should be followed by safety certification from licensed gas and electricity technicians and or manufacturers or warranties.

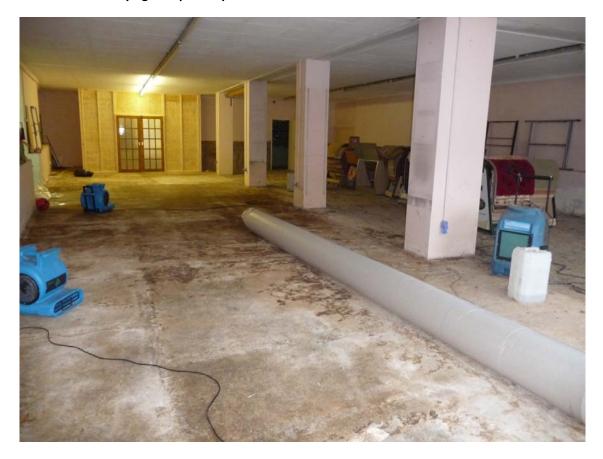
Photo 11 Belfor drying a carpet shop

This carpet shop was submerged as others in the same high street to a height of about 4 feet. Belfor one of the worlds largest restoration companies have installed one dehumidifier and two fans with a 13 amp heater to warm the air and aid evaporation in this 15000 square feet (15000)approx cubic feet double shop. The owner can expect to have a considerable wait until the shop dries or Belfor decide to install more equipment which in light of the time line since the flood should perhaps have been at hand?

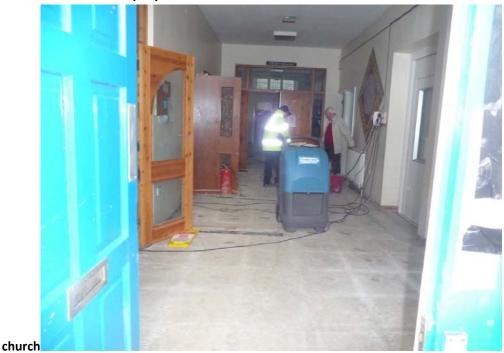
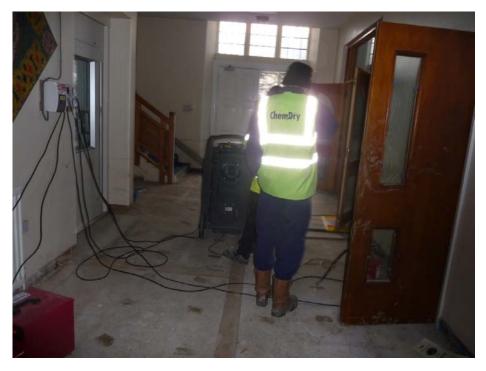
Photo 12 & 13 Chemdry dry a

The church was badly affected by flood waters. Leaving the doors open isn't really good practice when you install a closed drying program which is the only way the blue dehumidifier will work.

In the absence of heat or air movement, both required in this type of closed drying installation, there is no chance of the church drying out with this equipment set up. Leaving the doors open is probably

doing more good than the equipment. Insurers appear to be needlessly paying for equipment and technicians.

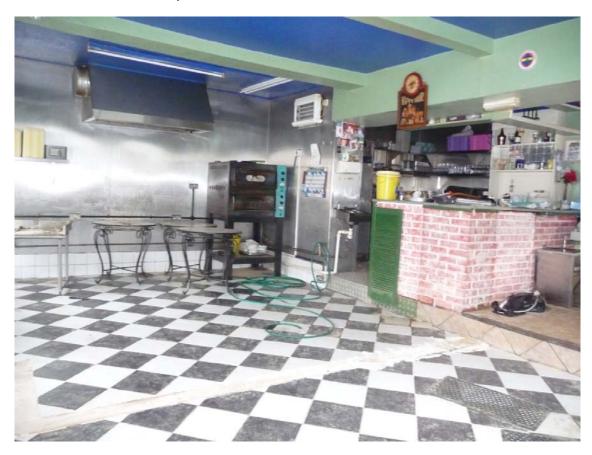
# Photo 14 Uninsured recovery?

This photo was taken through an open door. It shows the evidence of hard work, scrupulous cleaning and effective sanitation. It shows a common sense approach to salvage and subject to confirmation I would guess it was the work of an uninsured owner?
