INDEPENDENT AUDIT (2)

INSURANCE INDUSTRY RESPONSE to FLOOD AFFECTED BUILDINGS in CARLISLE 2005

Apathy or Ignorance?

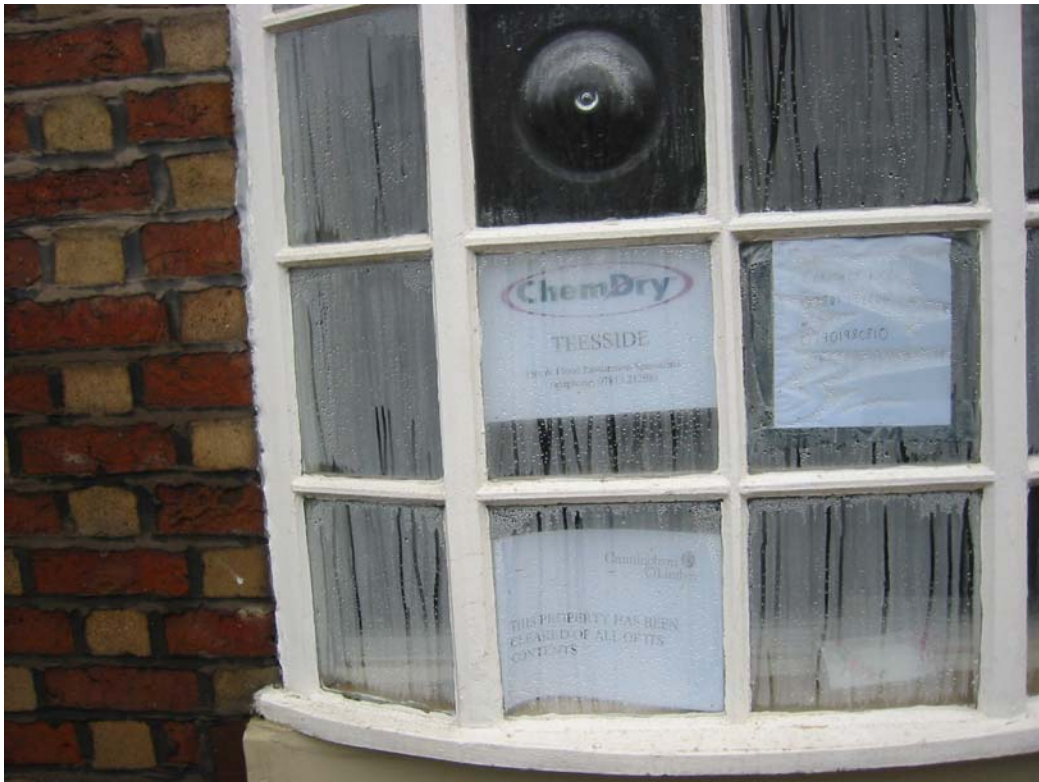
**Photo taken 4 weeks after the flood! 10th Feb 2005 in Warwick Rd.
Contractor and loss adjuster are proud to display their names!
The building is still wet and uncontrolled on all levels!**

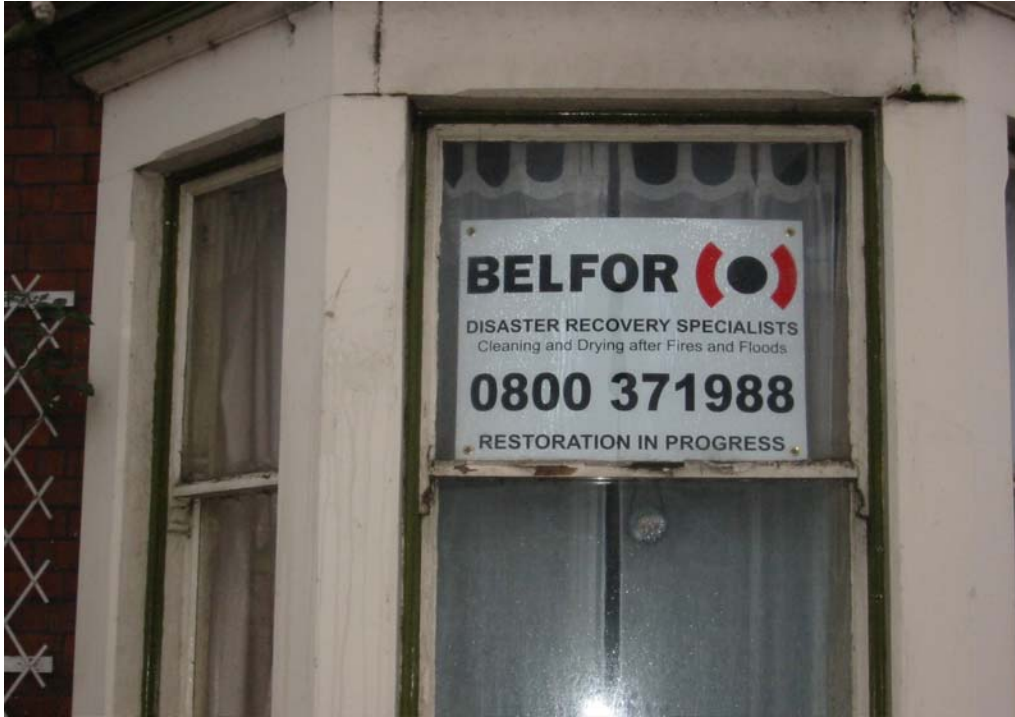
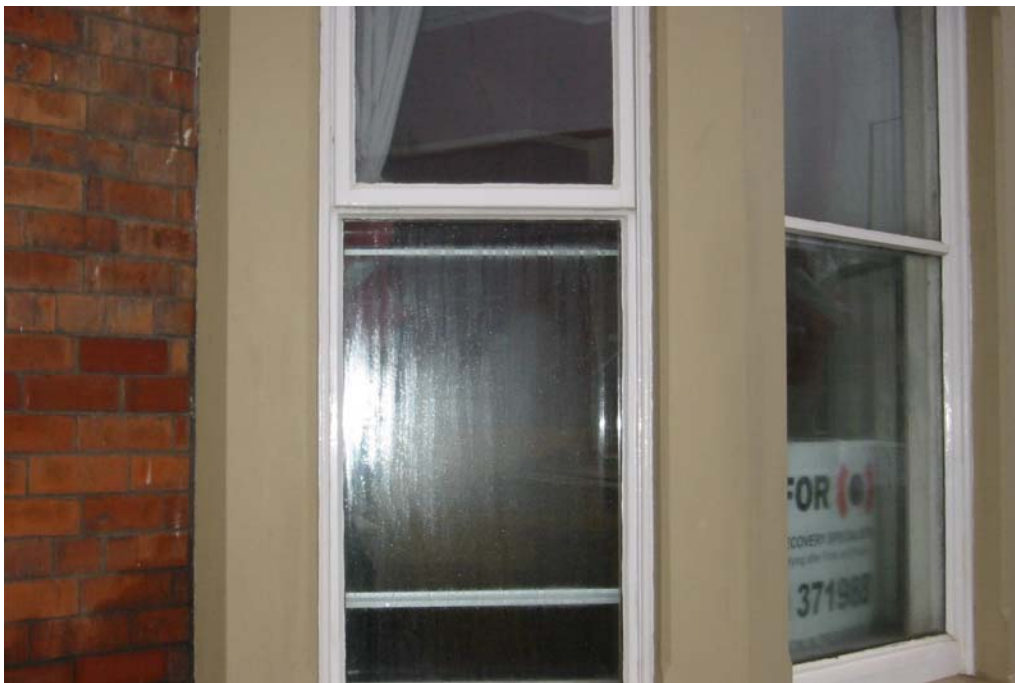
Both Raining inside!

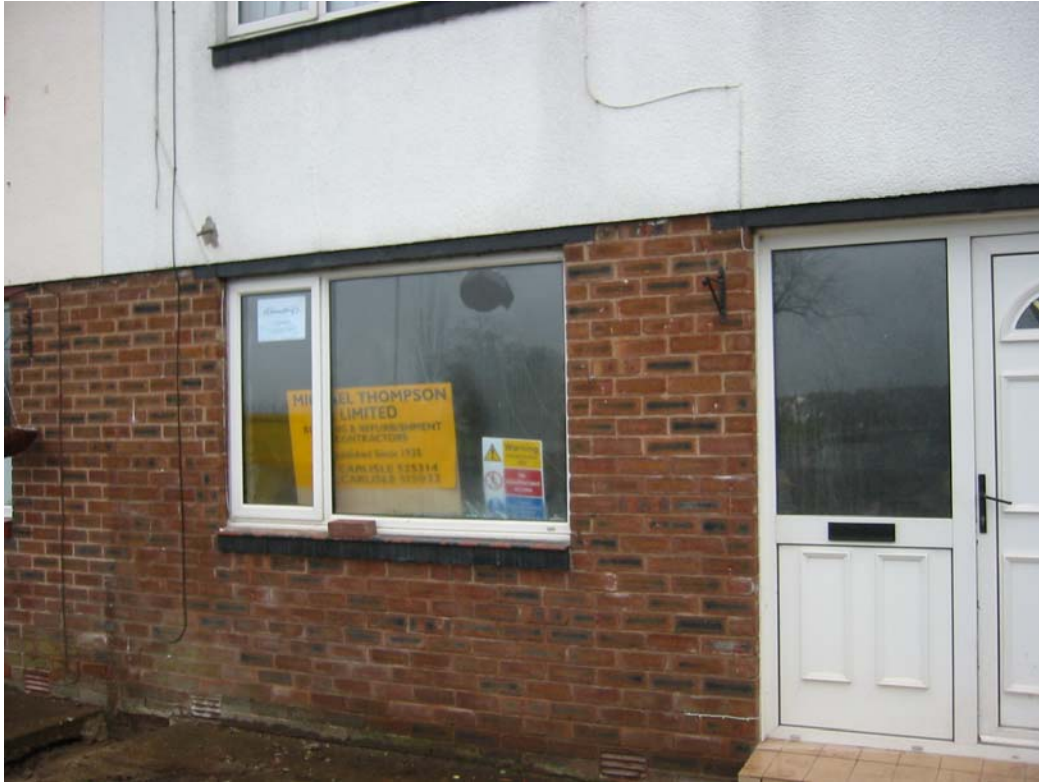
Raining Inside,

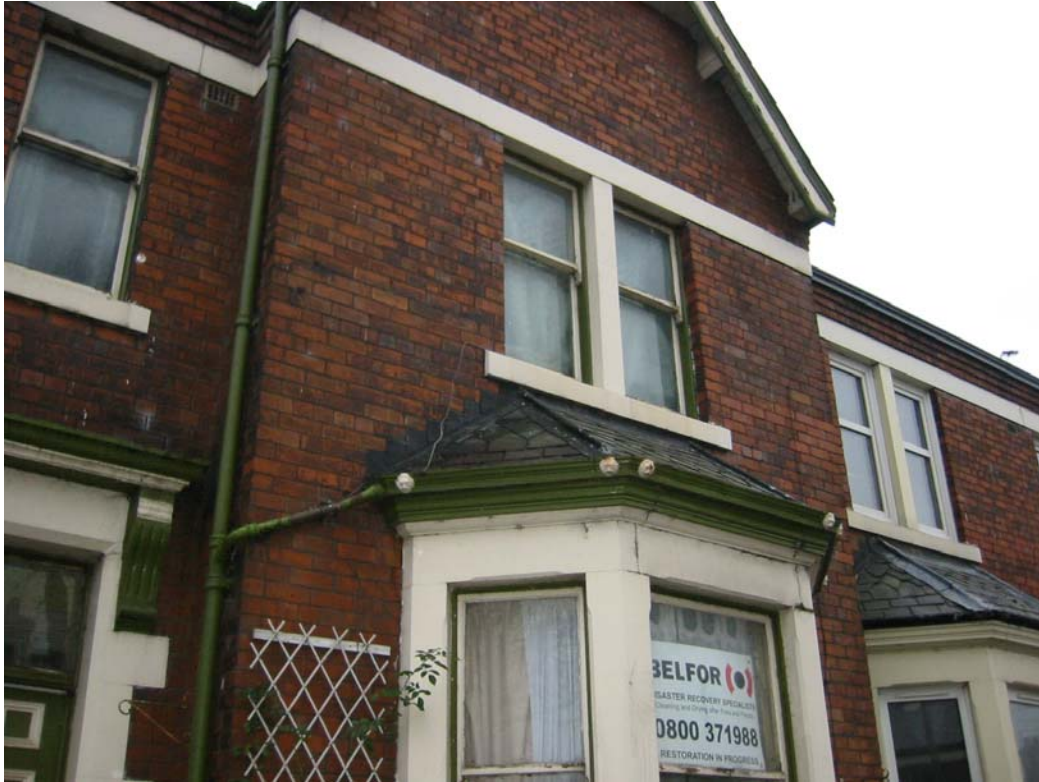
Upstairs.

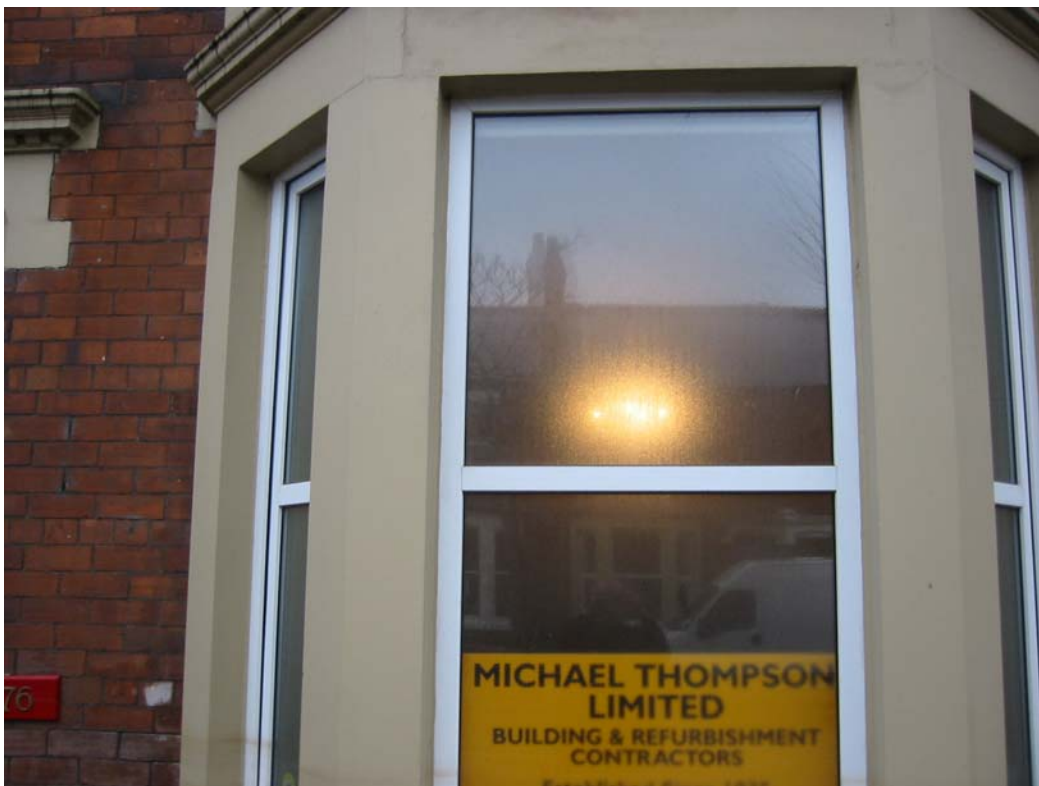
Raining Builder

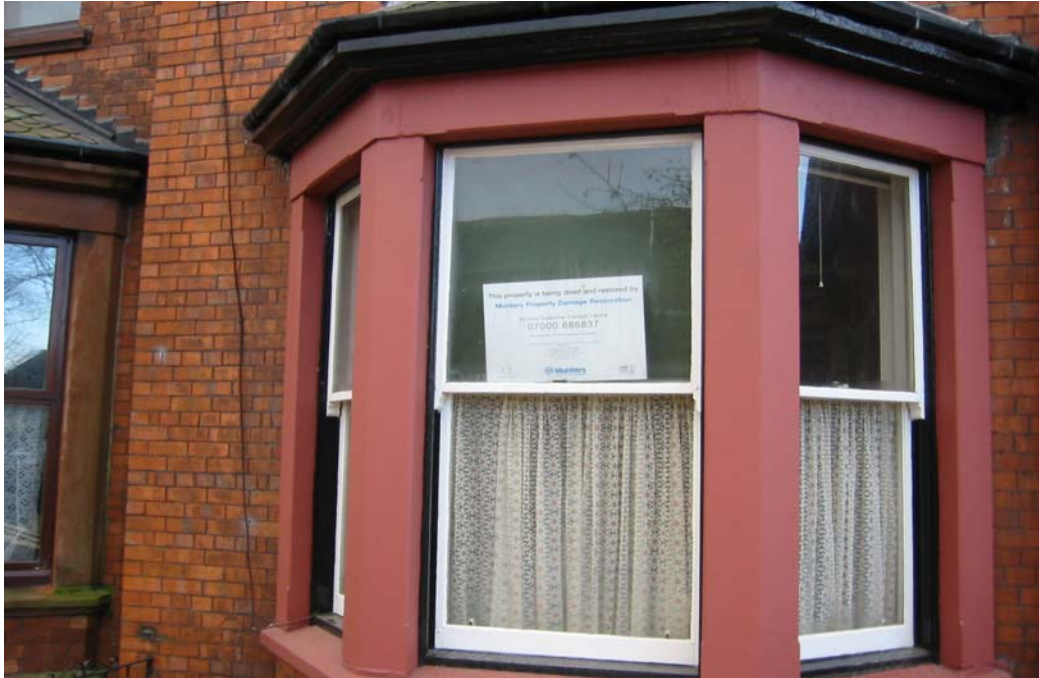
Condensation on windows from a company that knows drying !

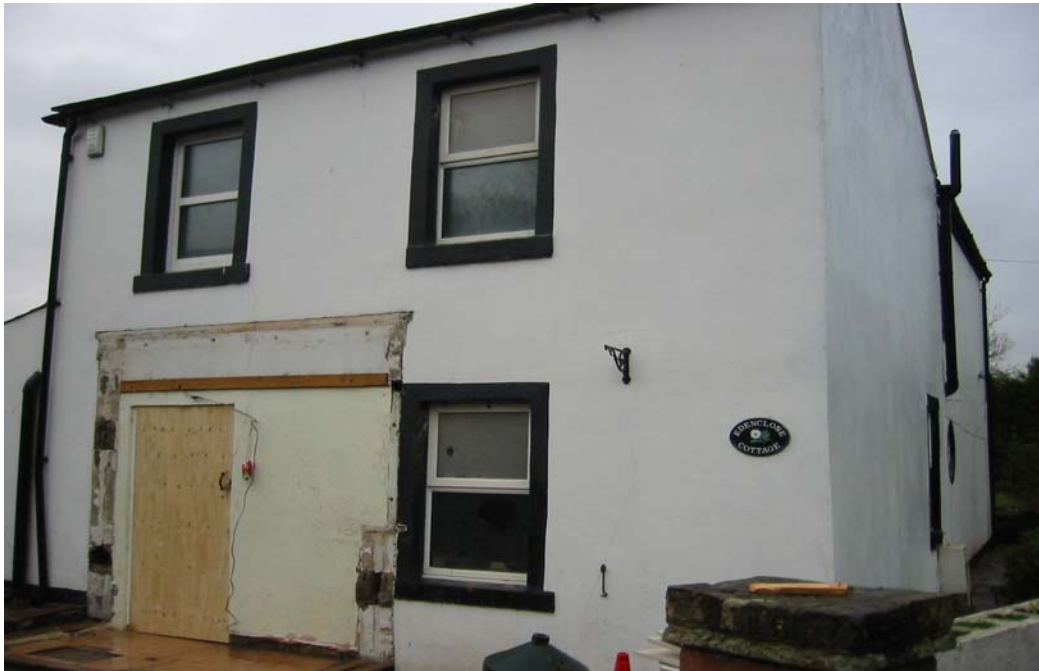
Remove floor, all plaster, woodwork, **even first floor was removed!** The cottage next door was stripped downstairs only? Free drying perhaps?

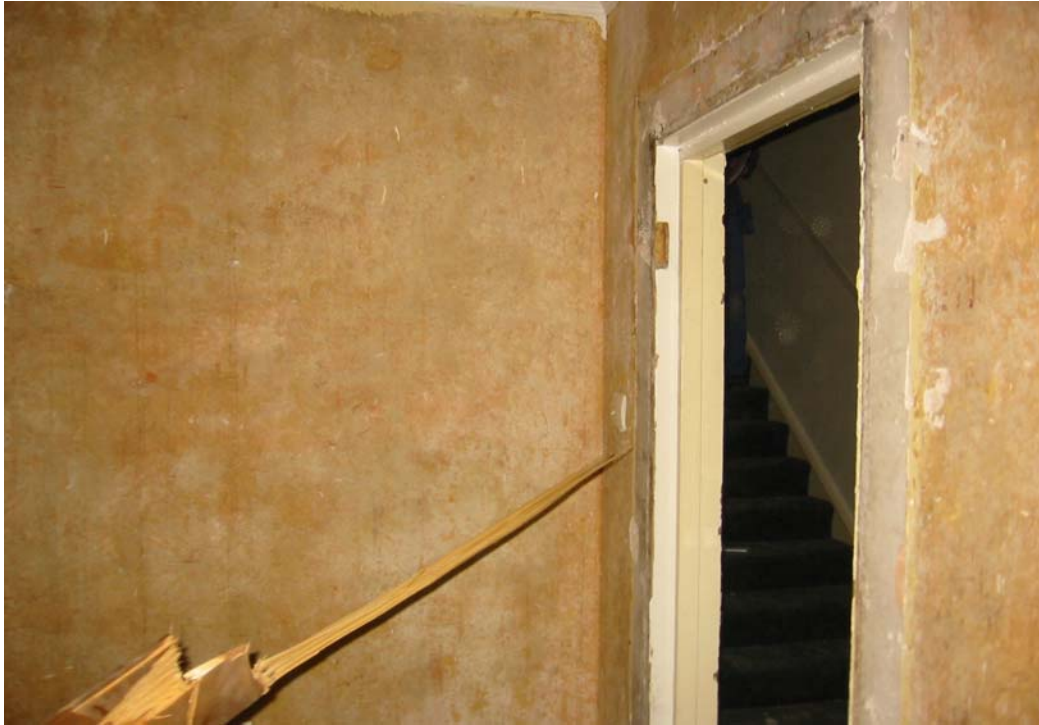
If all wet materials and some that are dry are cut out, drying costs can be reduced to zero. Building costs may escalate but is free drying too good to miss? Note the paper under the wet floor board and wet joist, the dust on top of the power socket! Both buildings were DRY!

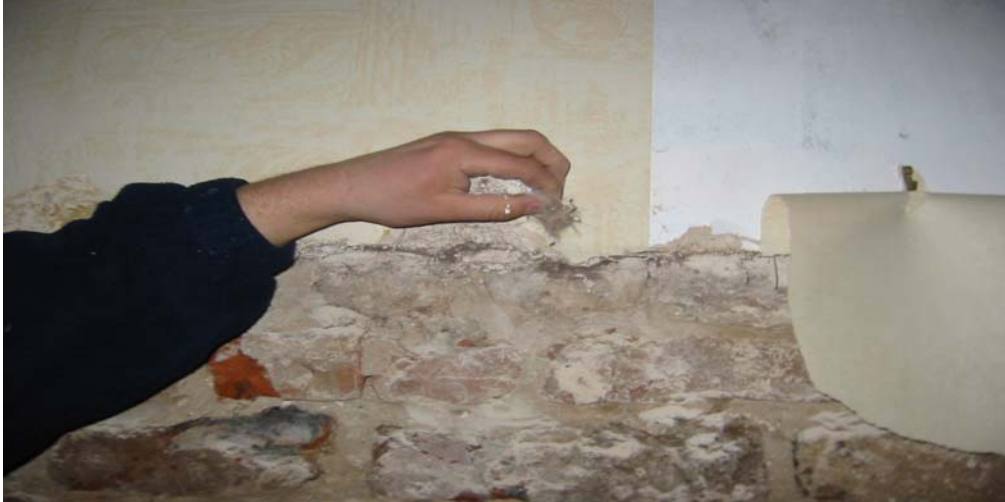
This strip out was being well done by a building company. This is a point of interest only, but can emphasise the specialist skills required in restoration.

The hydraulic lime plaster had a fibre component obviously to give it some strength and flexibility.

If you said number three you would be correct. Horse hair was used as a binding. Anthrax was common place in 18-19century and most people then had immunity, due to constant animal exposure. Today very few people have natural immunity and a health risk existed here.

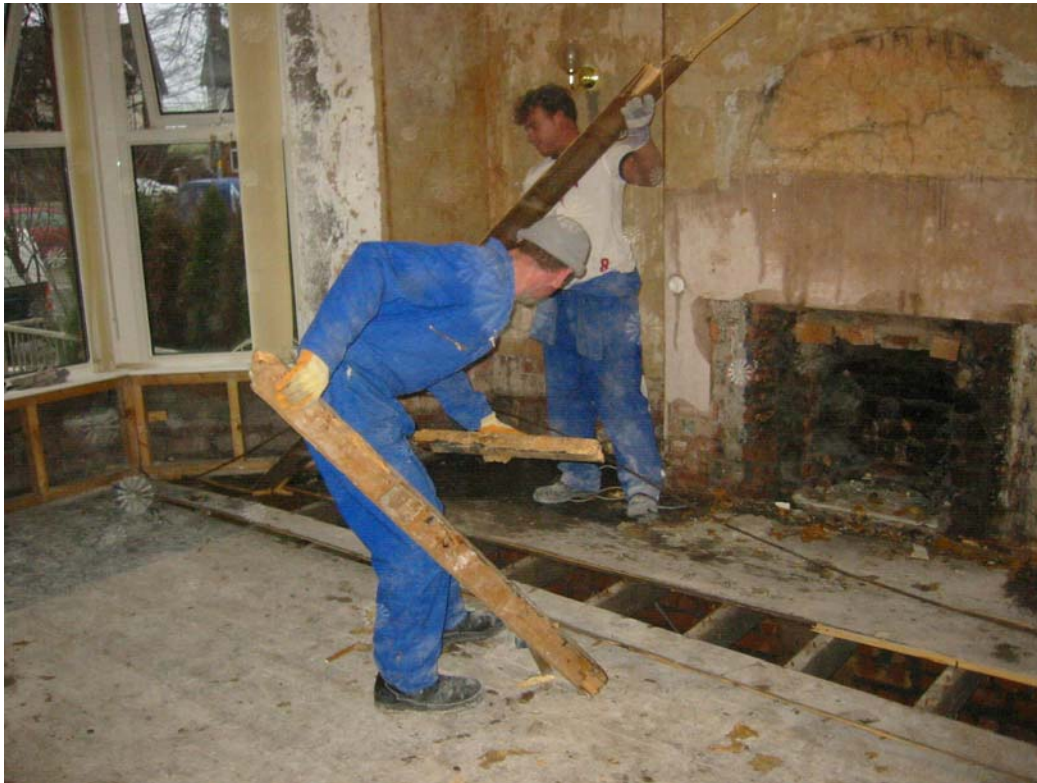
**Wall paper, plaster and floors going. Unnecessary cost to insurers £100,000
Disruption and loss of business to insured?**

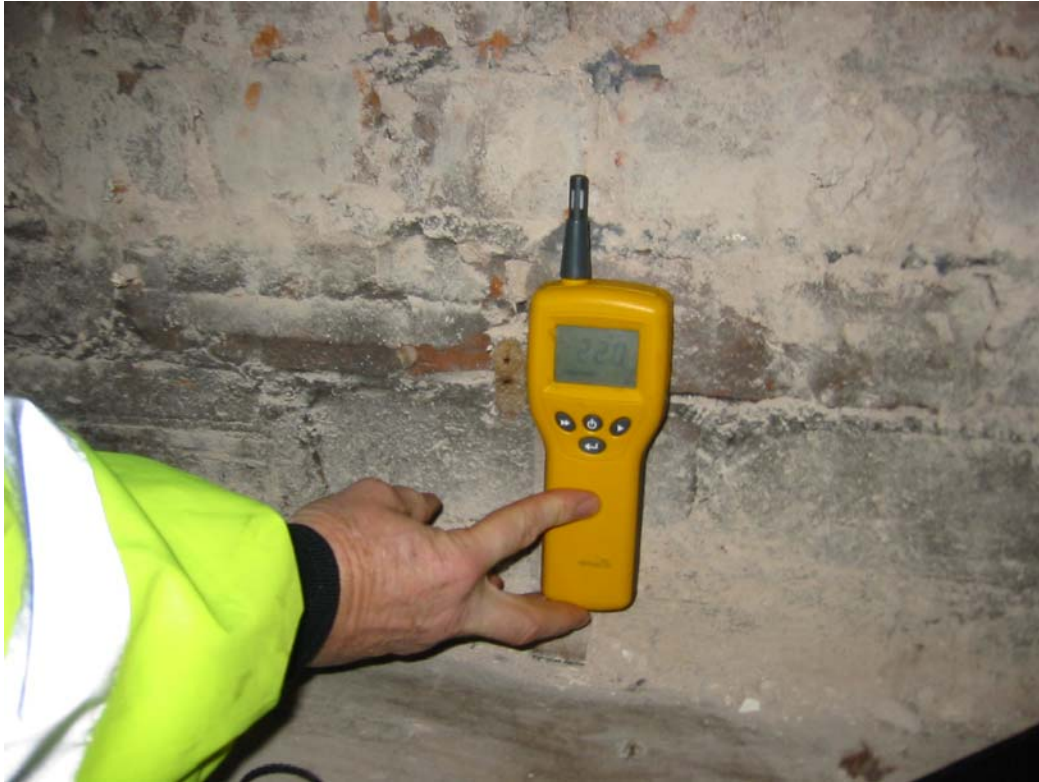
22% wme wood moisture equivalent = approximately 6% moisture content

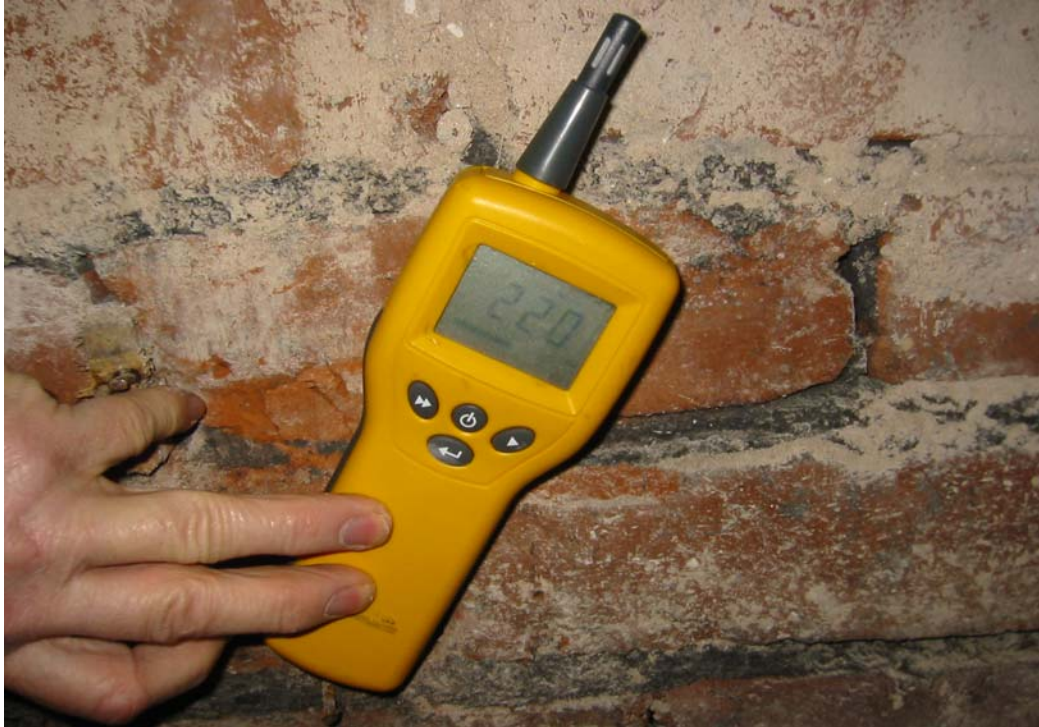
Different room 6% moisture content.

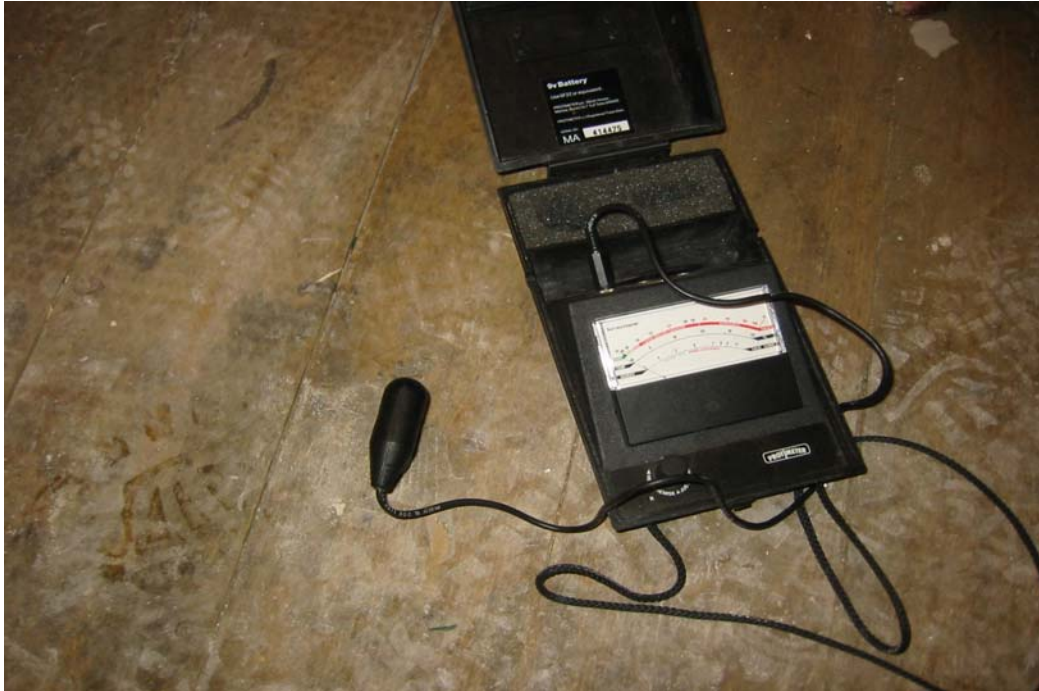
Dry floor boards

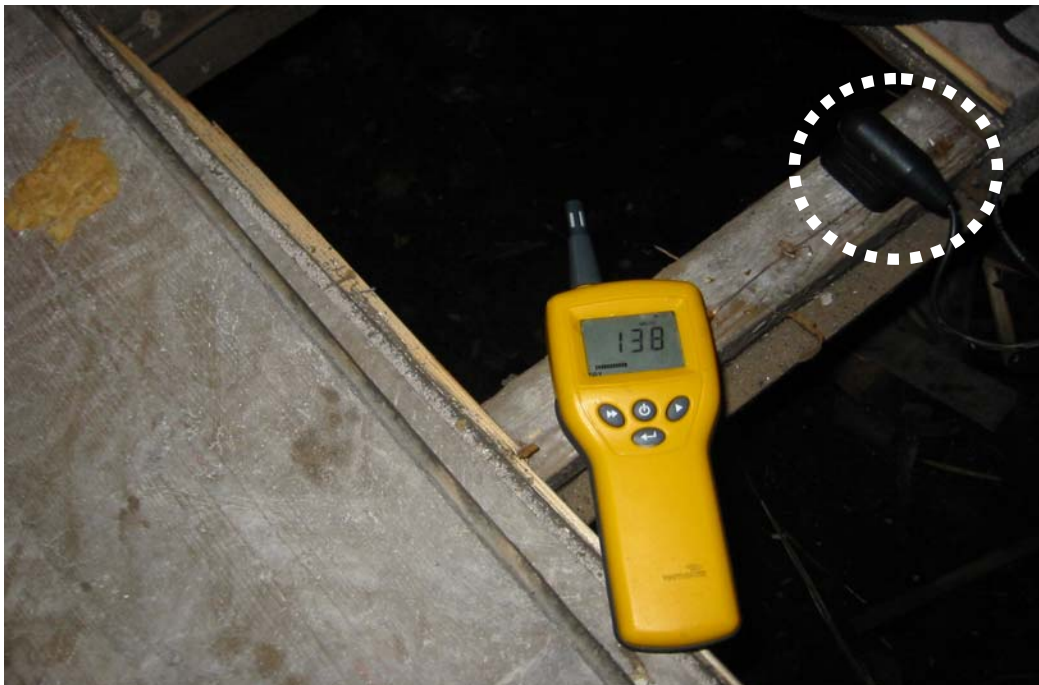
Joists at 13.8% Using penetrative spikes. Acceptably Dry without drying!

My survey concluded that only part of the party wall and an area below a bay window, were appreciably wet. Both areas may have been historic damage.

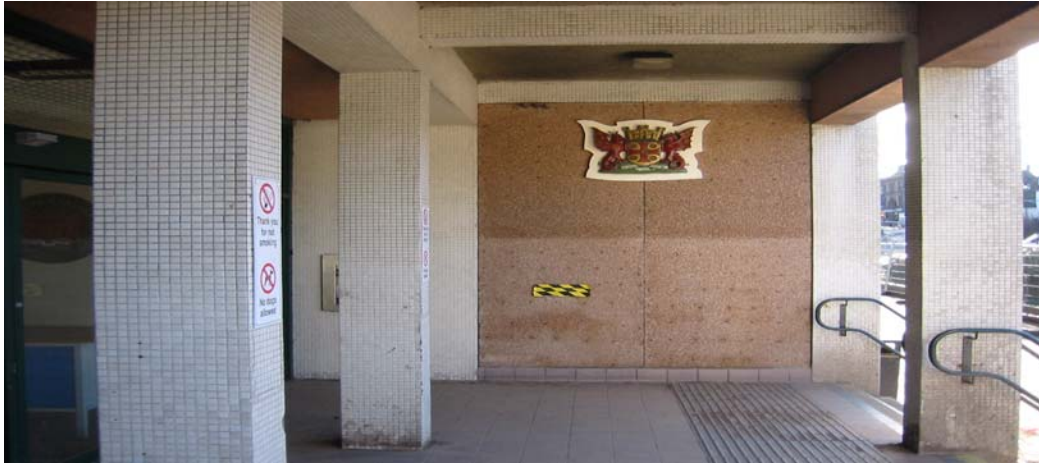
Flood line, 4 steps above pavement! Remember the whole of the basement, engineering services, and storage was submerged!

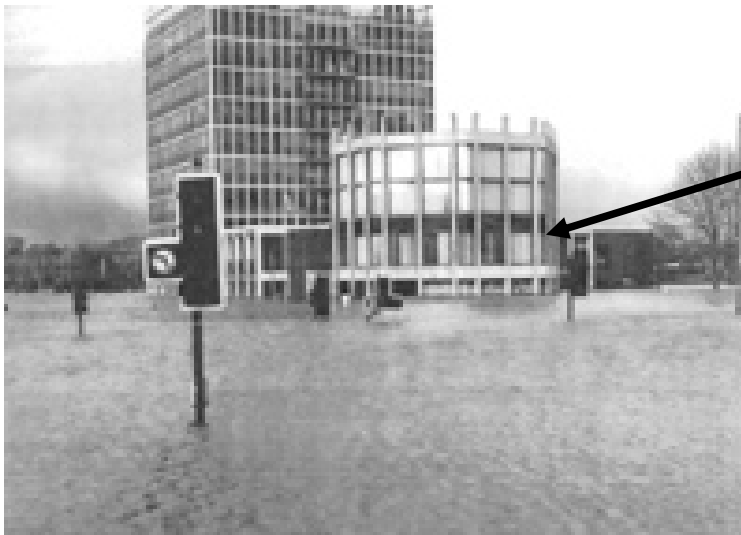
**The Assembly Chamber
See Page 15**

This is the view of the Civic Assembly Chamber 8th January By the 10th Feb only 1 piece of drying equipment had been installed, one 2 KW electric fire!

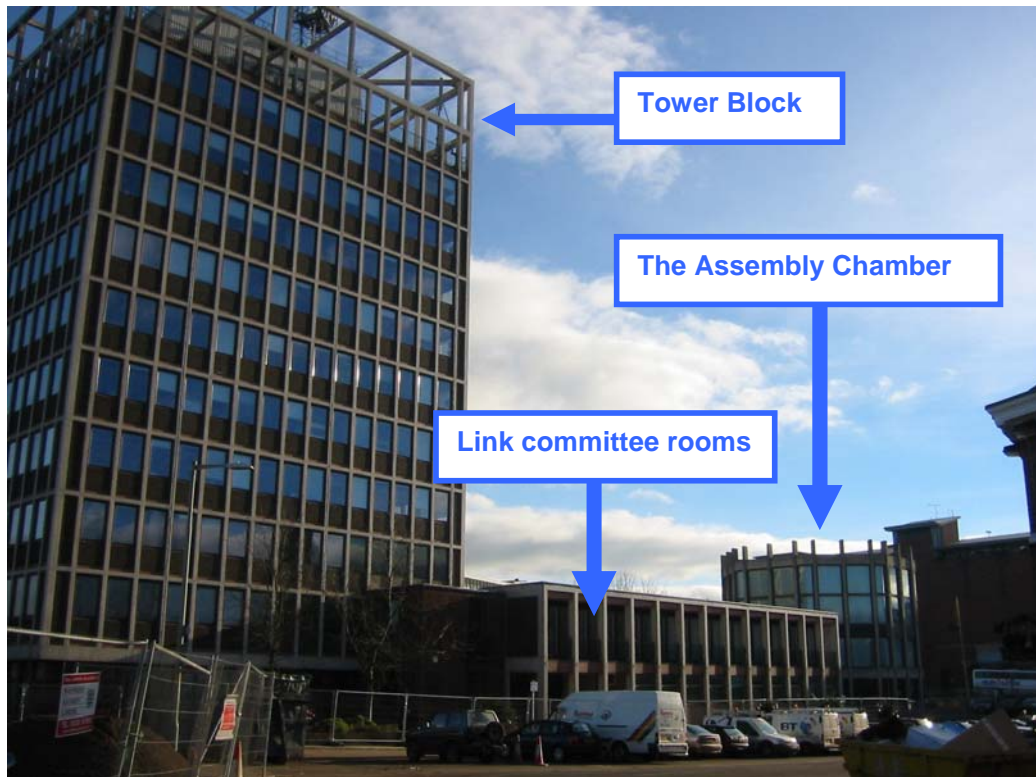
No equipment seen in the Assembly Chamber or library committee rooms (Link building) in over 4 weeks! Only the tower block had any drying installed.

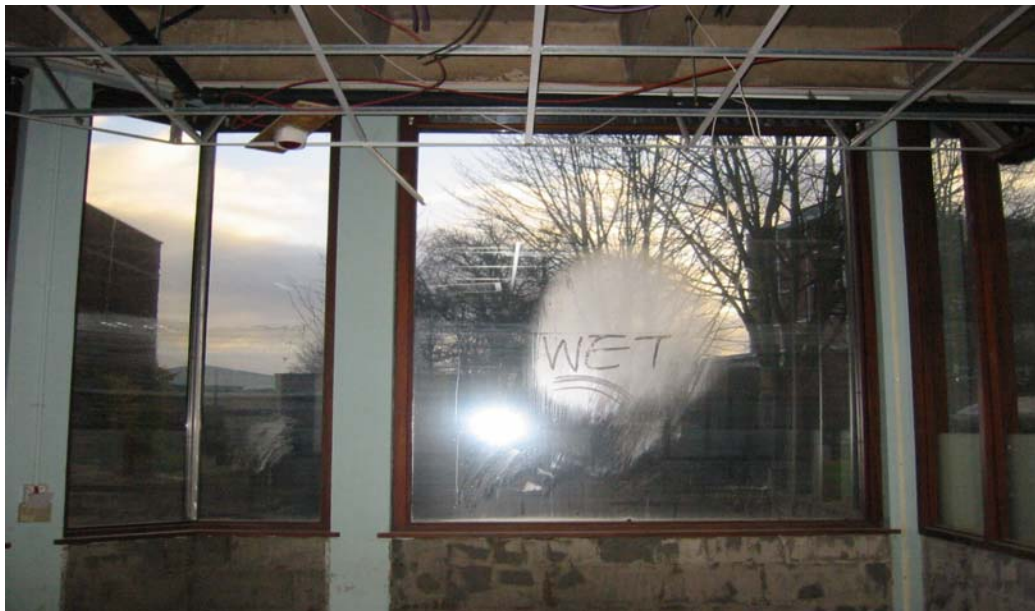
This is the ground floor of the round assembly chamber. Walls have been stripped, floor and building envelope saturated. No drying equipment installed, uncontrolled evaporation, doors open to both main tower and link building. The humidity is so great it is forming on the windows even with doors open!

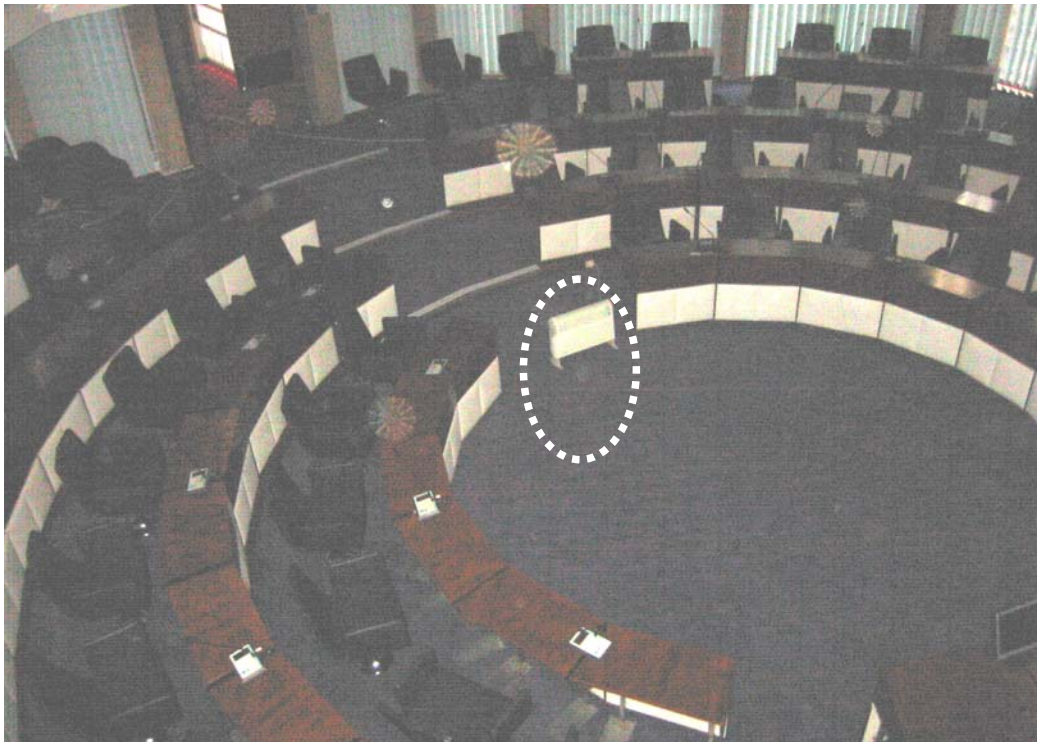
The chamber is high quality wood and leather and is on two floors, Photo taken from the upper gallery. The circle shows the use of one 2 KW electric heater. The only controls in the entire building. Is there a risk of mould? Is this apathy?
Can this really be seen as claim management in 2005?

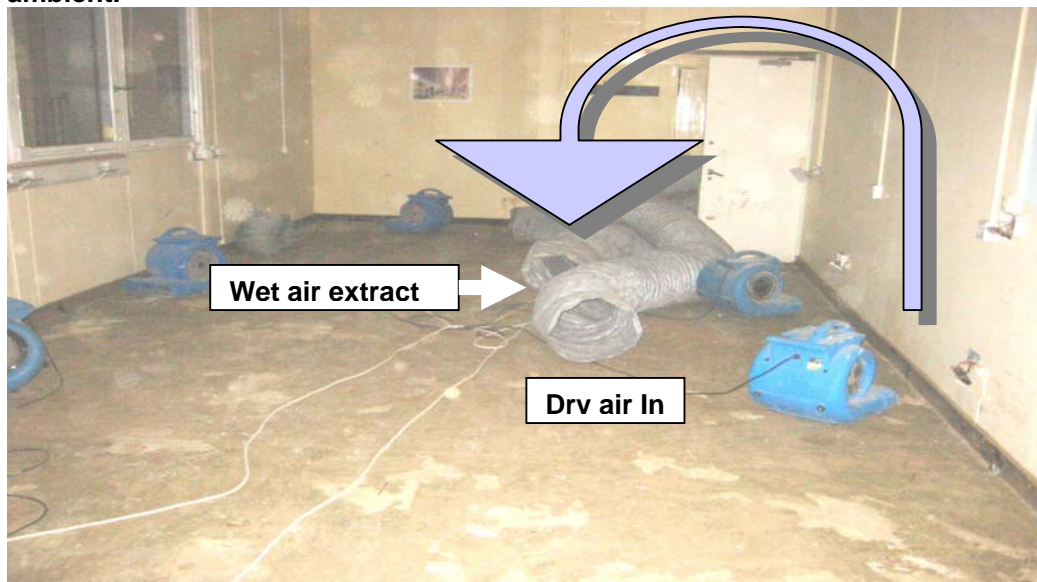
Dry incoming air being blown in vortex towards extract! Not very efficient!

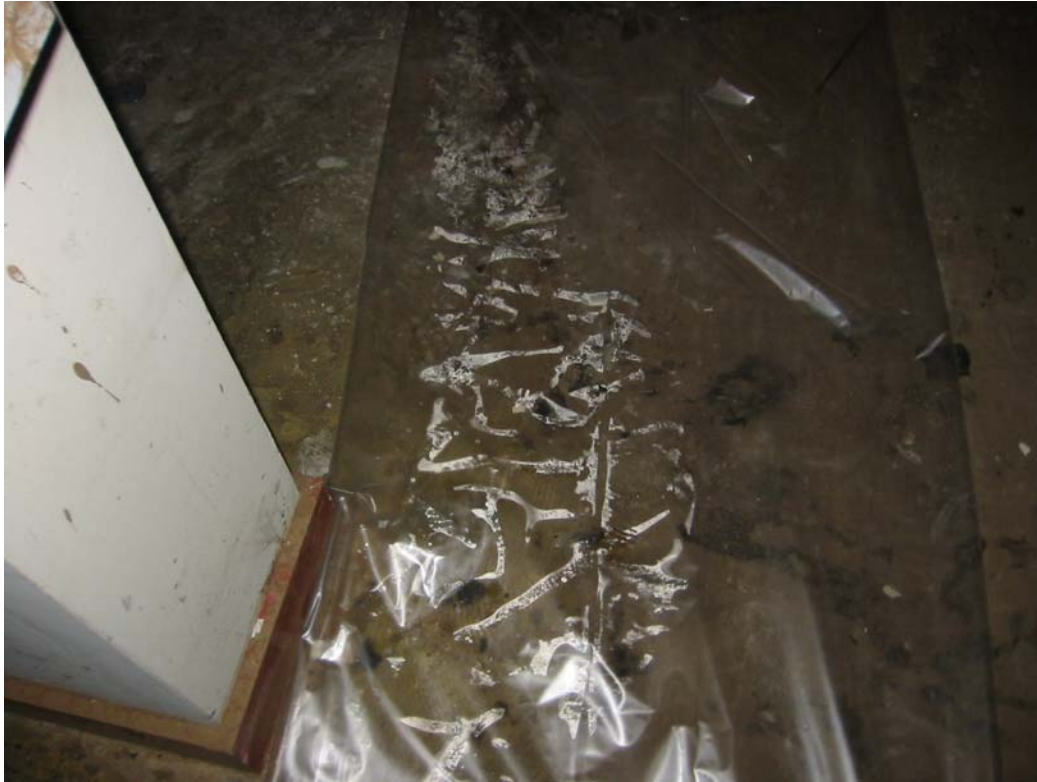
This picture tells a story on its own. The deflated polythene tubing is believed to be from the disconnected supply from the trailer mounted dryer in the following pictures. The plastic now deflated has caused a vapour barrier and condensation can be seen underneath. This is a very good visual on just how wet the building is. When can the council relay floors? How unnecessary is this delay? The drying program and controls should have been installed weeks ago!

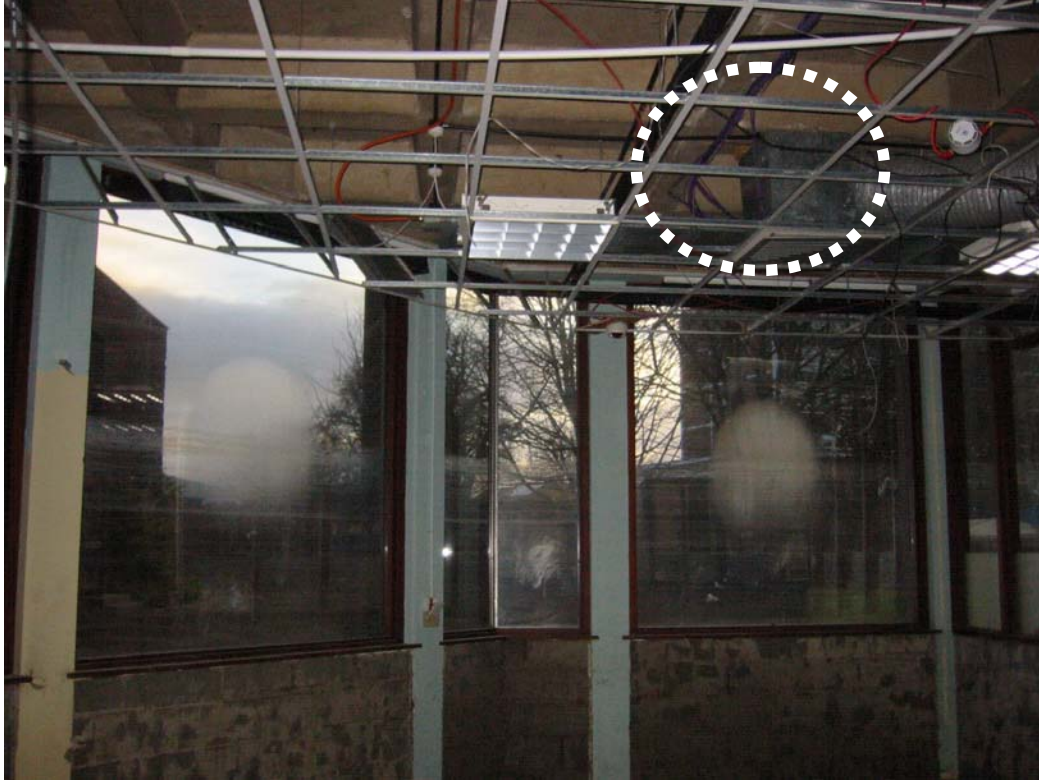
High level ductwork above flood level but see condensation on windows and obviously will form internally as duct is and not insulated, note the duct end is not sealed (circle) and will transport contamination throughout building when air movement, doors, windows are moved.

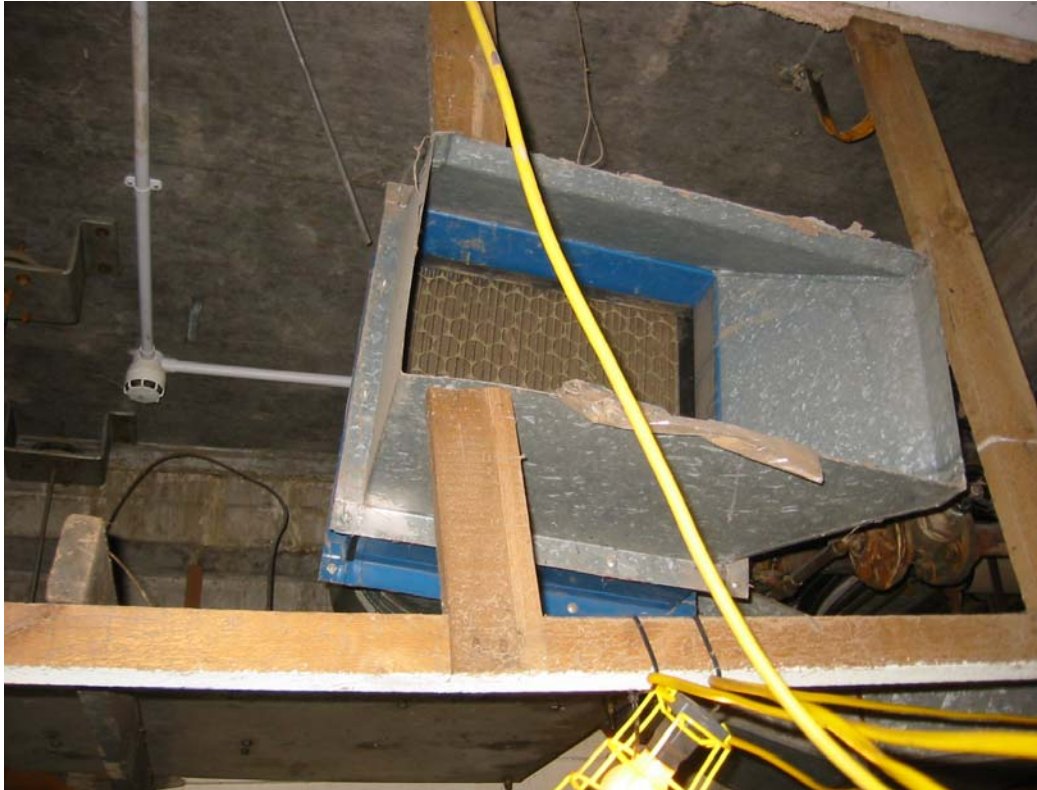
This is a duct at soffit level in the basement, previously totally submerged in black water. The whole system is contaminated and may contain standing water. A serious legionella risk! See debris on lips of duct. Consider the biological growth potential in that sodden filter or debris within the ducting.

A possible criminal liability and responsibility for the insurer who nominated the claim management company. Corporate manslaughter charges could be brought against those in charge of this project (Insurer CEO) if a fatality occurred. Fatalities do occur in legionella outbreaks. Has a suitable risk assessment been undertaken or is the health of several thousand people entering the building down to luck?

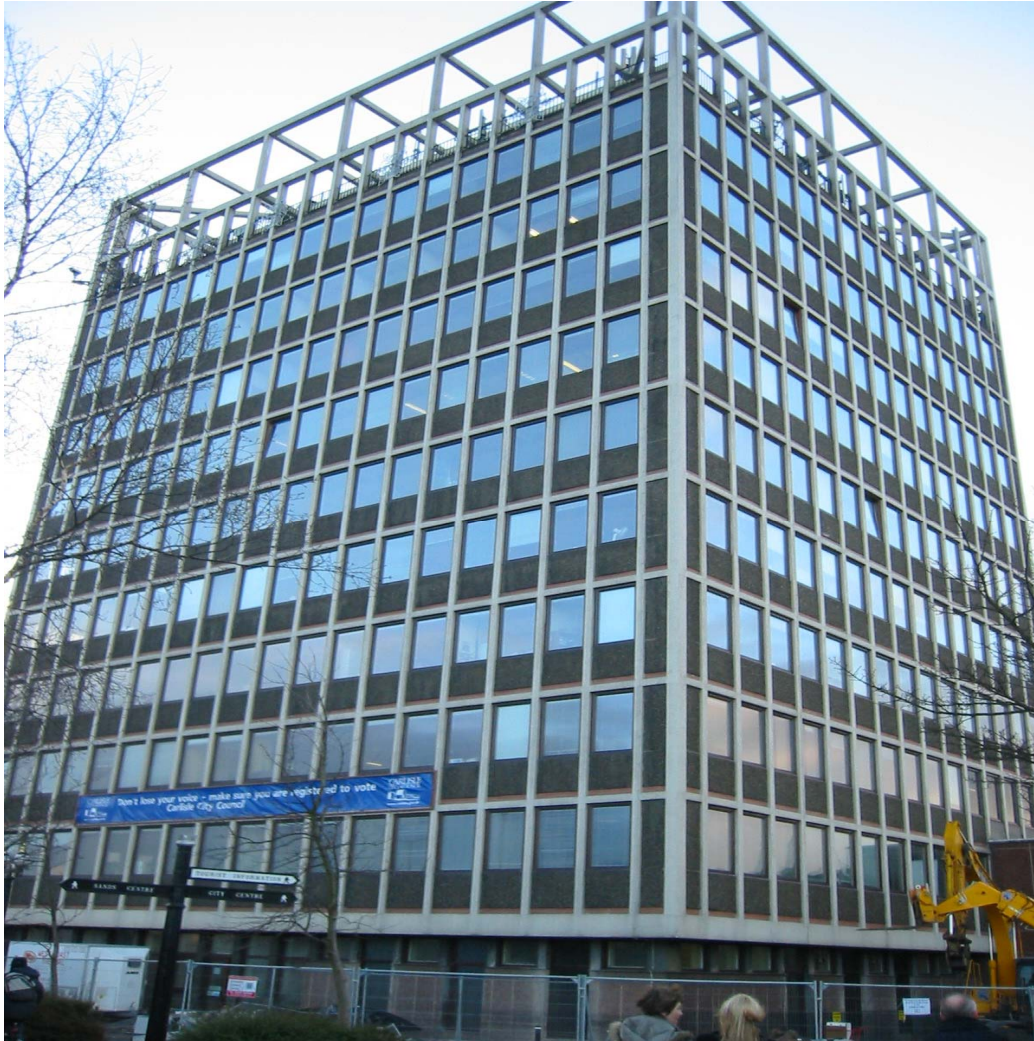
HOW NOT TO DRY A FLOODED BUILDING

Turn up the heating, close the windows.

**Could there be a better example of claims incompetence?
Is this a reasonable criticism, have you seen anything worse?**

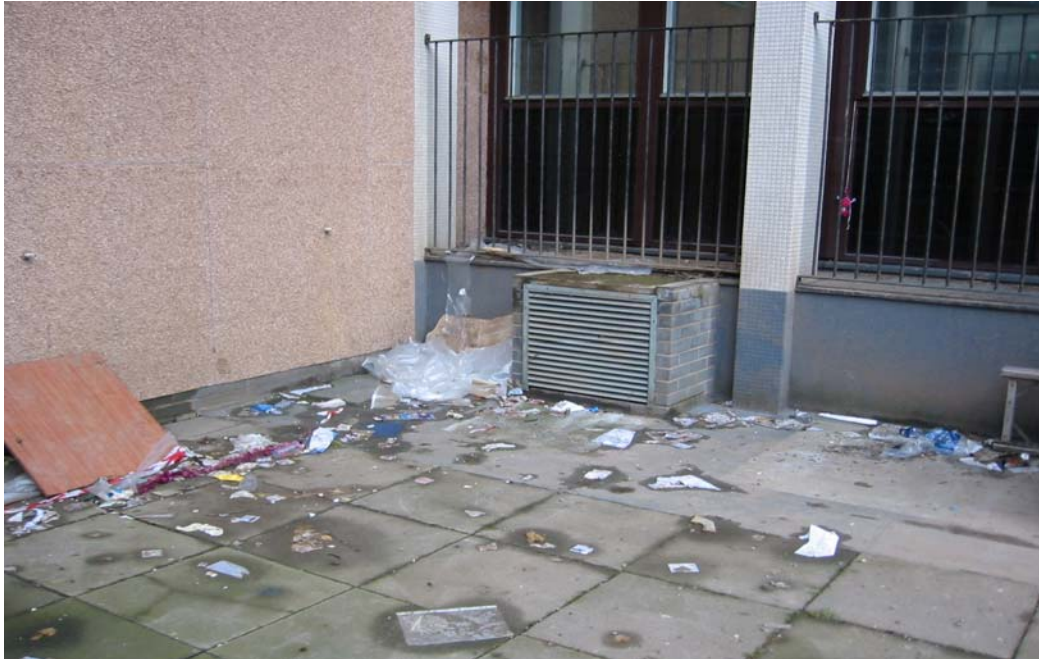
This photo shows additional ductwork which was underwater but not sealed or disconnected? Cold air entering the building, causing dew point and resultant condensation resulting in unnecessary secondary damage? Bio risk?

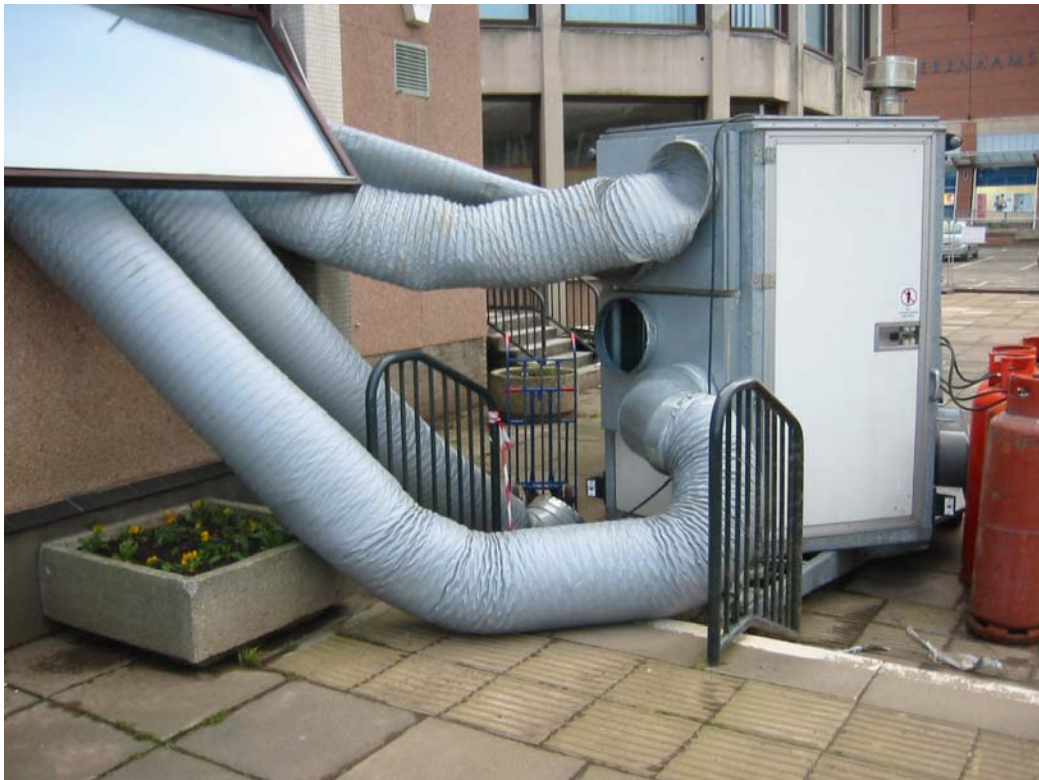
This photo shows a trailer mounted system poorly installed with a collapsed hose, top, and disconnected hose bottom. The windows are not sealed either

allowing cold air to enter the drying area which may result in additional cold spots and dew point being reached locally. Condensation and mould potential. As I said in the previous audit, contractors and suppliers may have explanation for items identified in this report.
