# **ASBESTOS MANAGEMENT SURVEY REPORT**

**St Vigor's Church Fulbourn,  
Manor Walk,  
Fulbourn,  
CB21 5BN**

**Reference No: 2067M-A**

**Survey Date: 03rd March 2014**

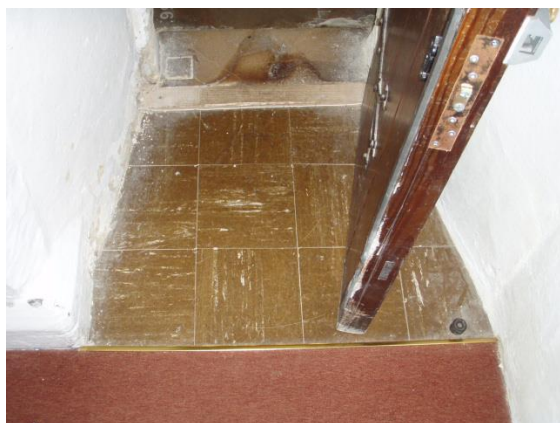
Comments:- Green floor tiles.

Recommendations:- No action required.

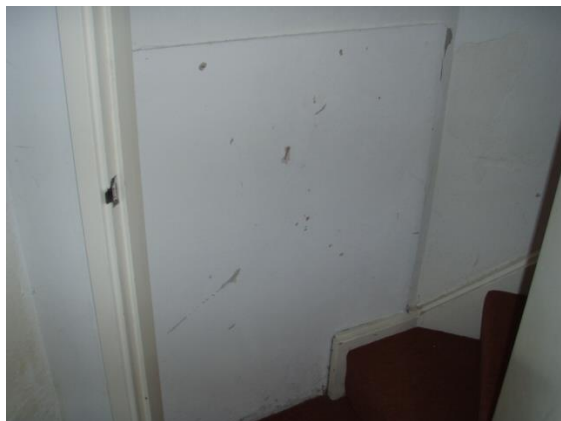
Comments:- View of fibreboard panel to wall. Non asbestos product.

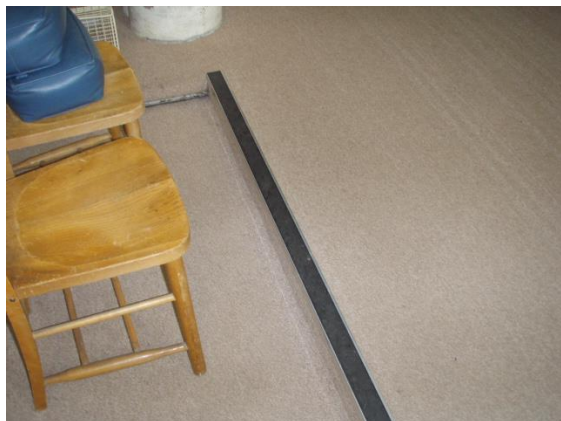
Comments:- View of modern rubber stair nosing. Non asbestos product.

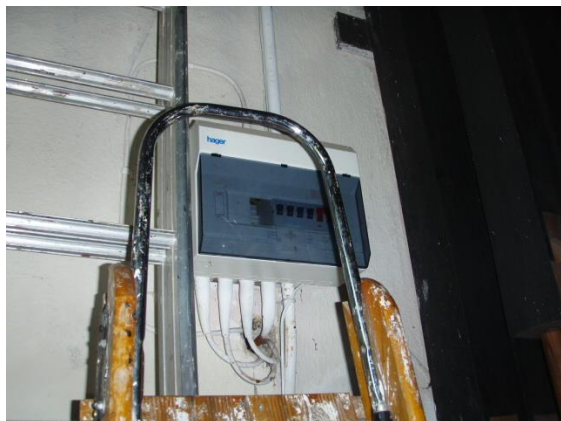
Comments:- View of modern electrical distribution board. Non asbestos product.

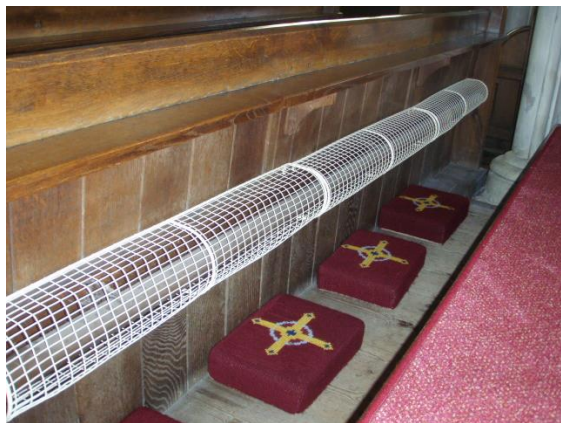
Comments:- View of No Access to internal of heater units. Live at time of survey.

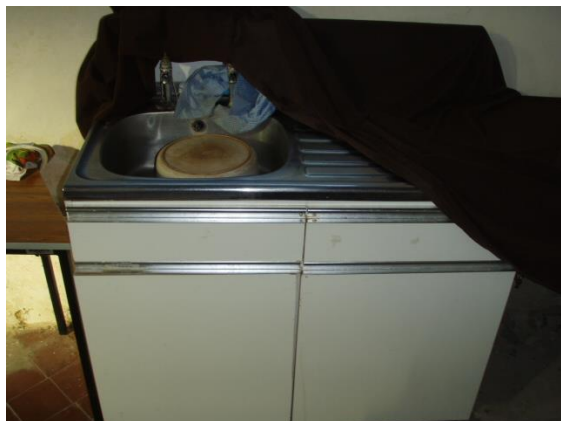
Comments:- Bitumen pad to underside of sink unit.

Recommendations:- No action required.

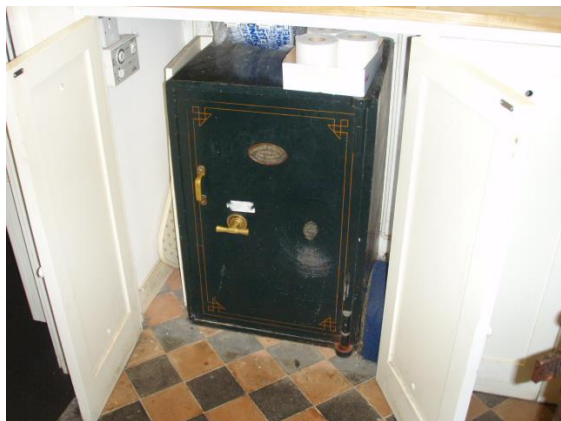
Comments:- No access within safe unit. Strongly presumed asbestos insulating board internal lining.

Good Condition

Recommendations:- Label and manage.

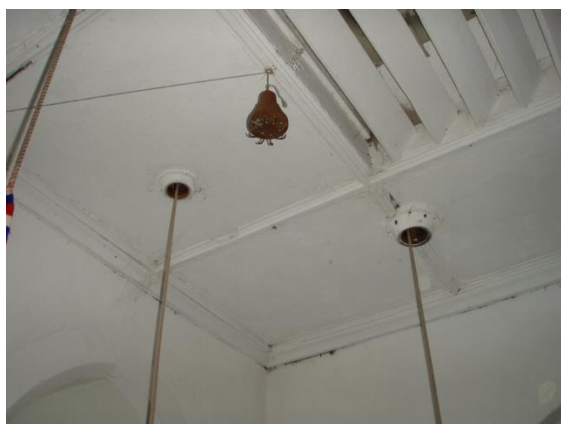
Comments:- Textured coating to ceiling.

Recommendations:- No action required.

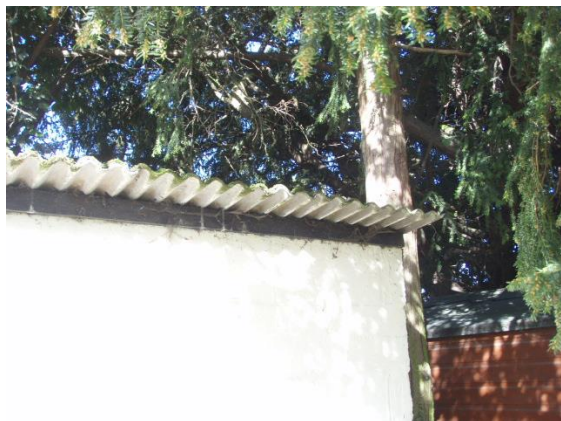
Comments:- Asbestos cement roof sheets.

Good Condition

Recommendations:- Label and manage. Re-inspect periodically.

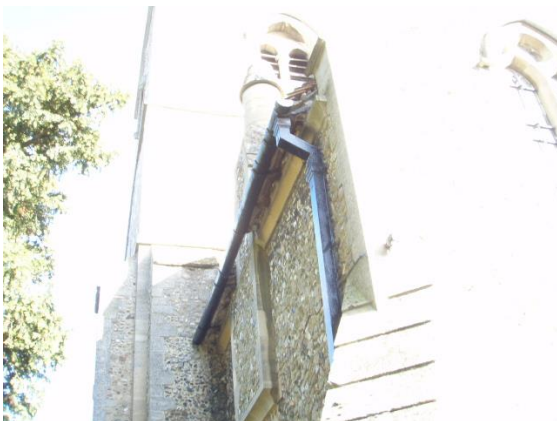
Comments:- View of metal rainwater goods. Non asbestos product.
