## **ASBESTOS MANAGEMENT SURVEY REPORT**

**The Parish Church of St Mary,  
Toller Street,  
Kettering,  
NN16 0JJ**

**Reference No: 2107M-A**

**Survey Date: 10th April 2014**

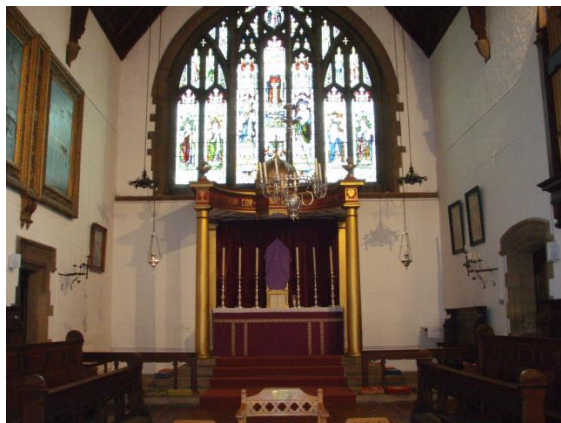
Comments:- View at ground floor level.

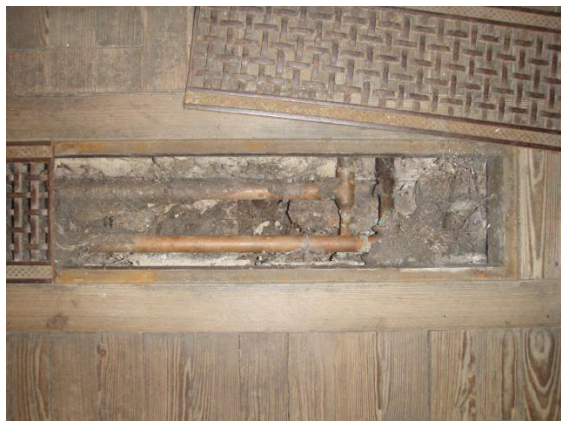
Comments:- View within floor heating duct. No asbestos detected.

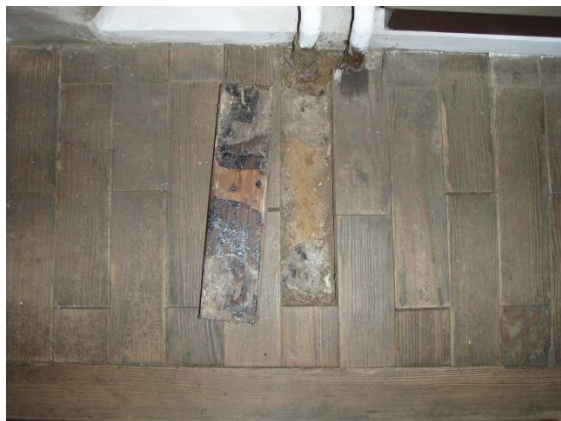
Comments:- Bitumen adhesive beneath parquet flooring.

Recommendations:- No action required.

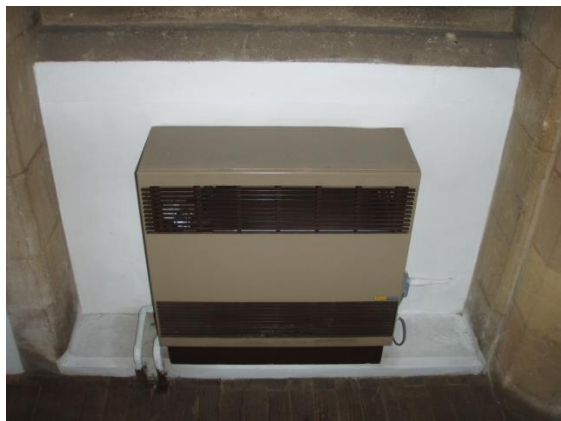
Comments:- View of heater unit mounted to solid wall. No asbestos detected.

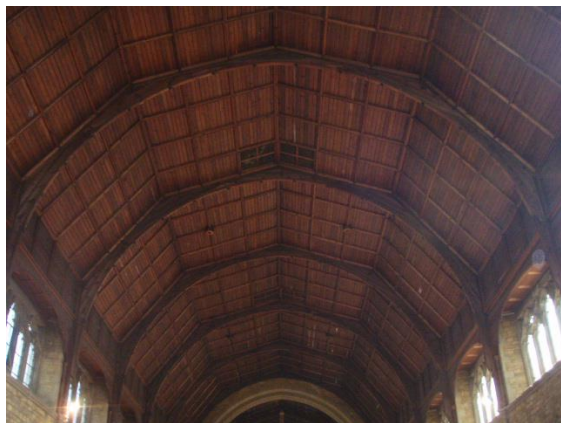
Comments:- View of timber underside to roof. No asbestos detected.

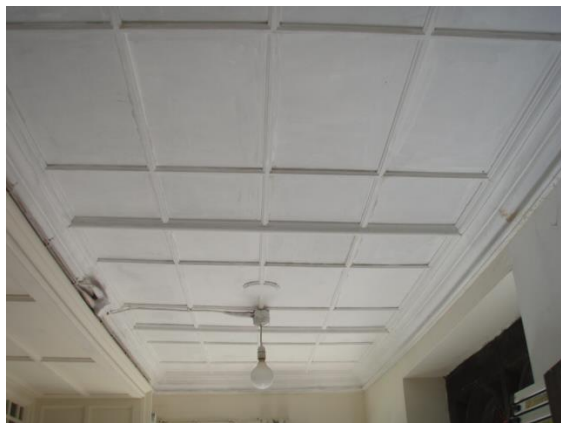
Comments:- View of decorative timber ceiling. Non asbestos product.

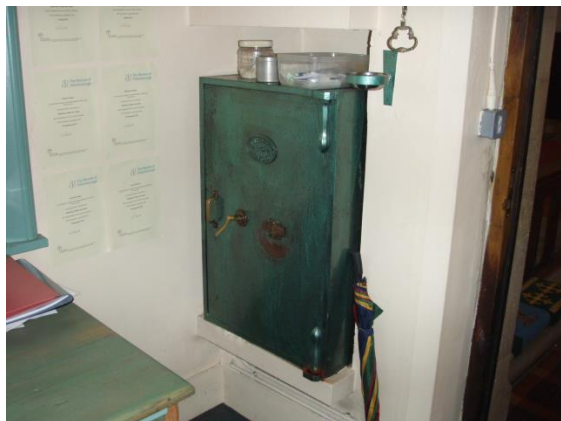
Comments:- No access within safe unit. Strongly presumed asbestos insulating board internal lining.

Insulating Board

Good Condition

Recommendations:- Label and manage.

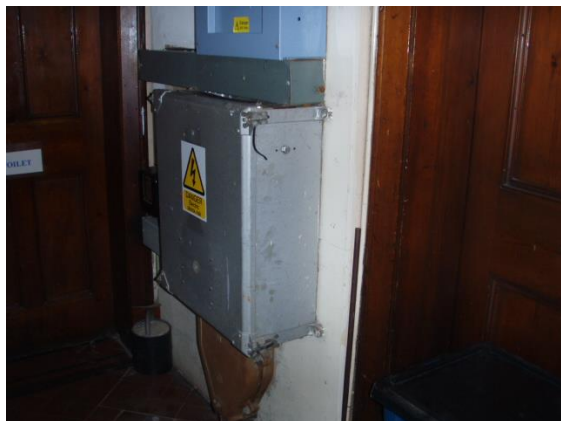
Comments:- No access within live electrics. Strongly presumed woven textile flash guards within.

Woven Textile

Good Condition

Recommendations:- Label and manage.

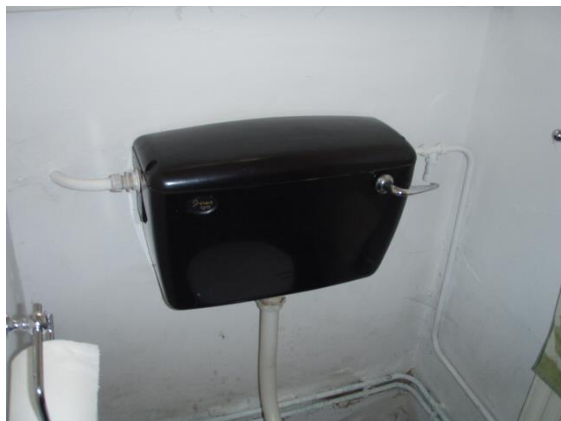
Comments:- Reinforced resin toilet cistern.

Reinforced Resin

Good Condition

Recommendations:- Label and manage. Re-inspect periodically.

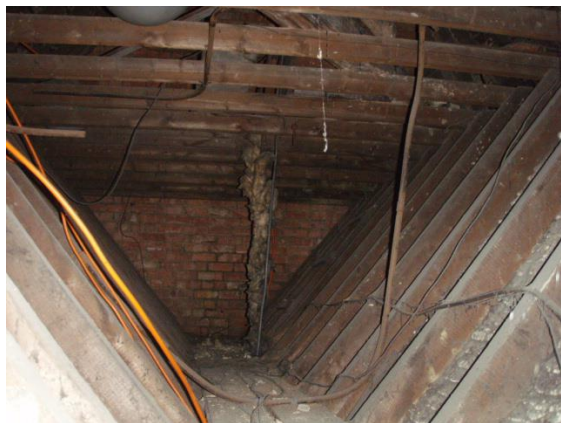
Comments:- View within roof space. No asbestos detected.

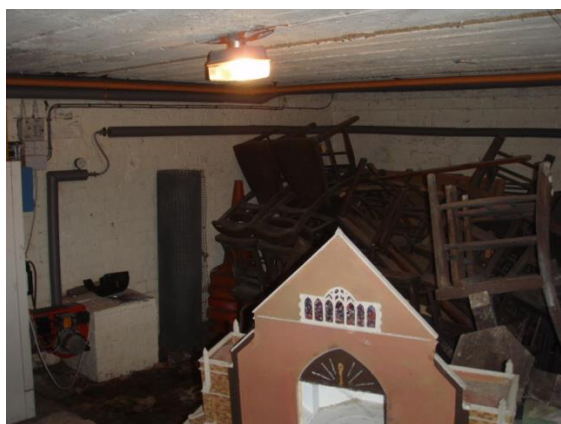
Comments:- View within boiler room. No asbestos detected.

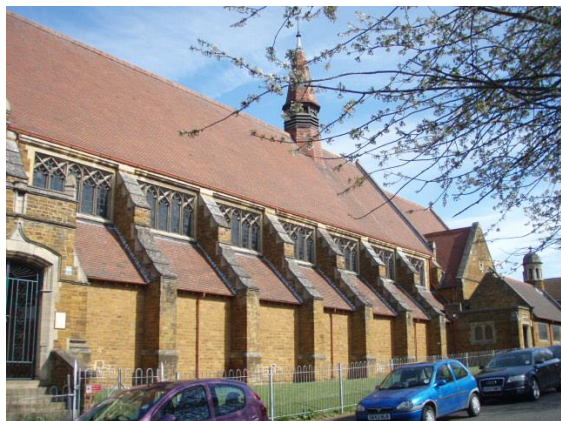
Comments:- View at front elevation. No suspected asbestos containing materials identified to external areas.
