## **ASBESTOS MANAGEMENT SURVEY REPORT**

**St Catherines Greek Orthodox Church,  
Friern Barnet Lane,  
Barnet,  
N20 0NL**

**Reference No: 2911M**

**Survey Date: 23rd August 2016**

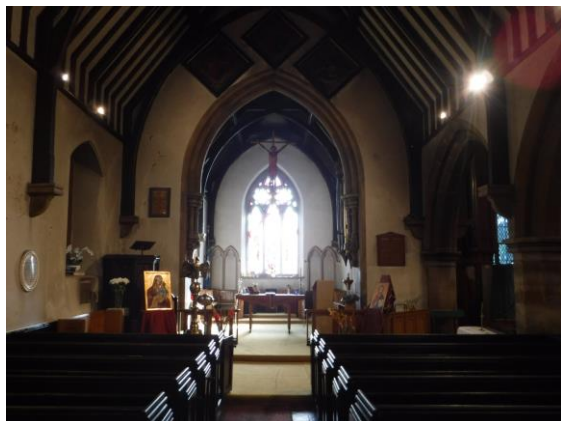
Comments: Typical view within church.

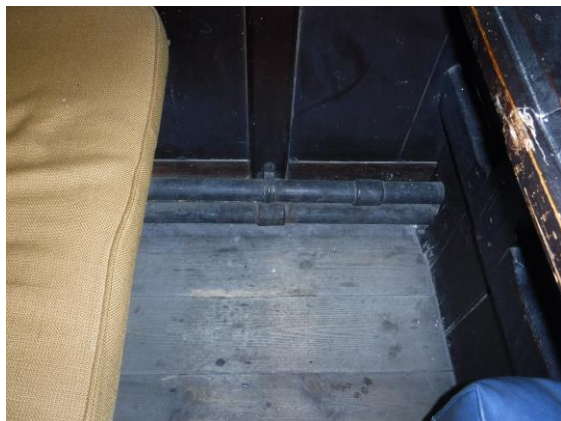
Comments: View of uninsulated heating pipework. No asbestos detected.

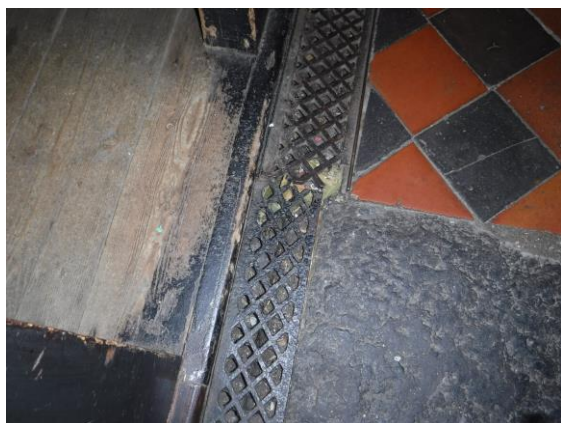
Comments: View of uninsulated heating pipework within floor duct. No asbestos detected.

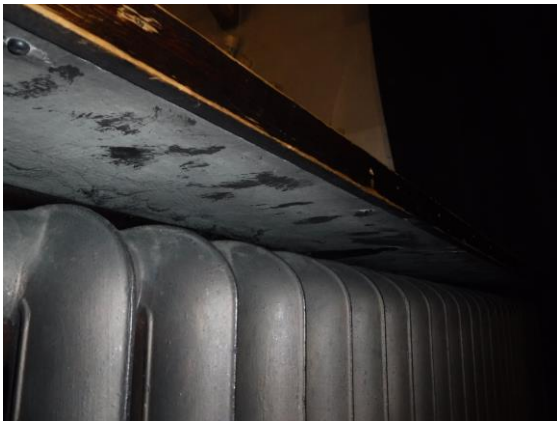
Comments: Asbestos cement panel to underside of shelf over radiator.

Good Condition

Recommendations: Label, manage and re-inspect periodically.

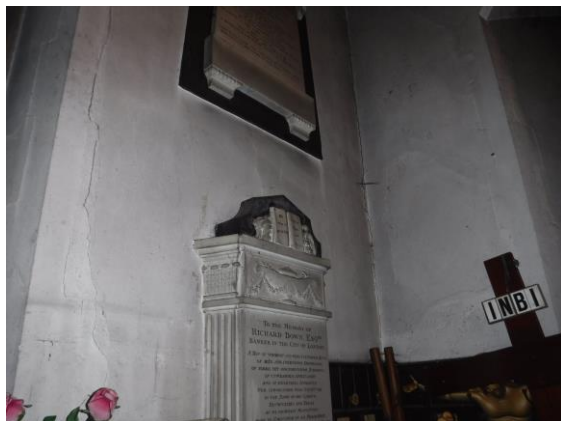
Comments: View of solid stone walls, common throughout. No asbestos detected.

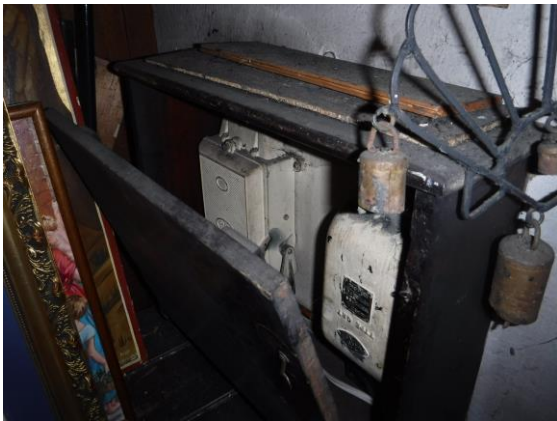
Comments: No access within live electrics. Strongly presumed woven textile flash guards within.

Good Condition

Recommendations: Label and manage.

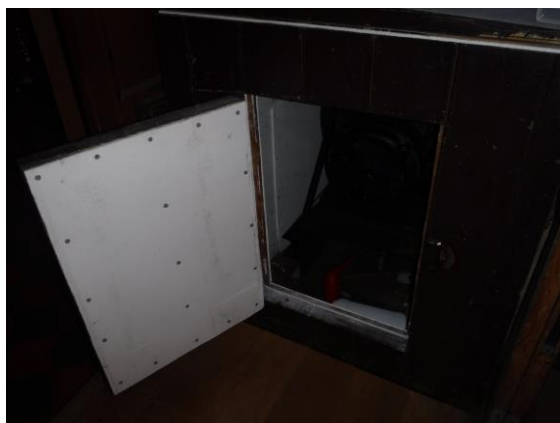
Comments: View of Glassrock insulating board lining to organ pump boxing. Non asbestos product.

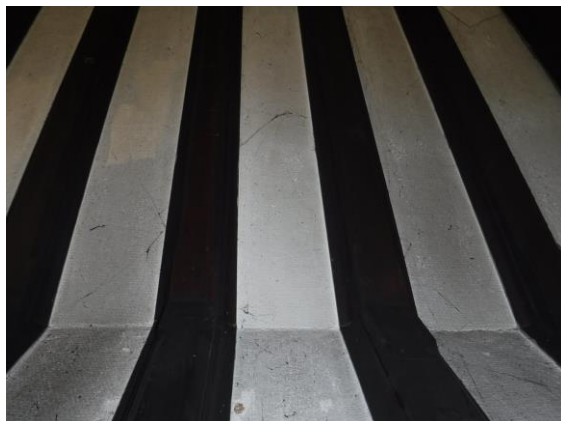
Comments: View of fibreboard panels to underside of roof. Non asbestos product.

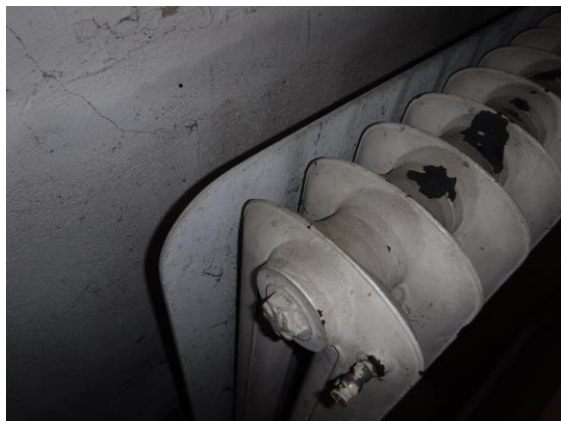
Comments: Redundant asbestos insulating board panel behind radiator.

Good Condition

Recommendations: Remove and dispose of following HSE guidelines.

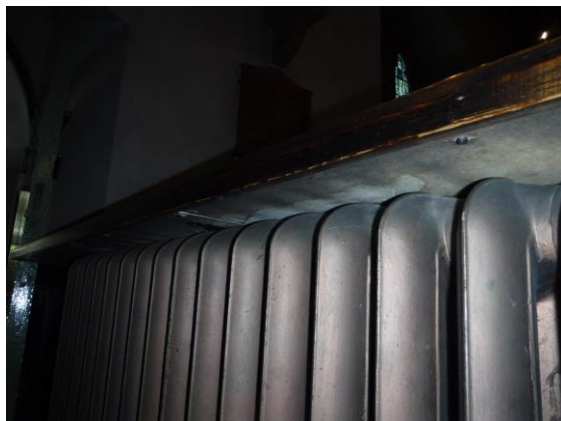
Comments: Asbestos cement panel to underside of shelf over radiator.

Good Condition

Recommendations: Label, manage and re-inspect periodically.

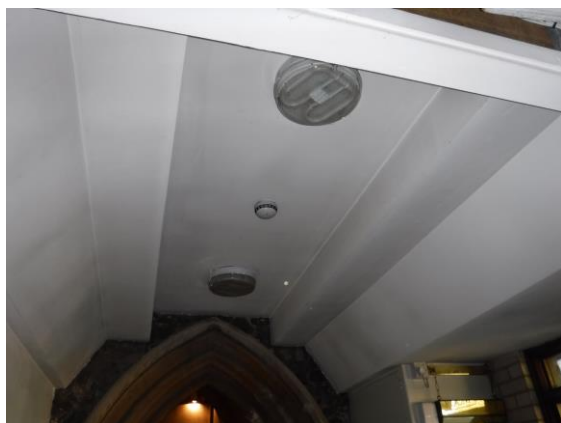
Comments: View of plasterboard ceiling. Non asbestos product.

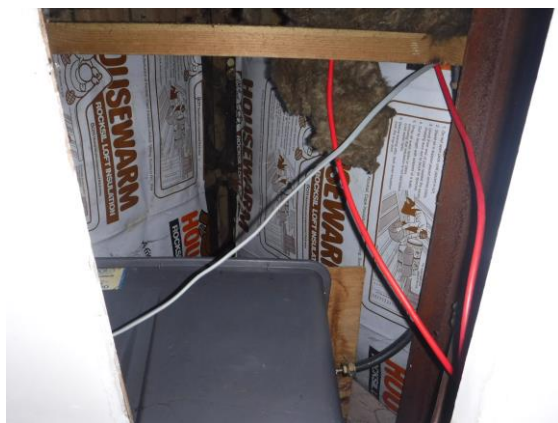
Comments: Typical view within roof space. No asbestos detected.

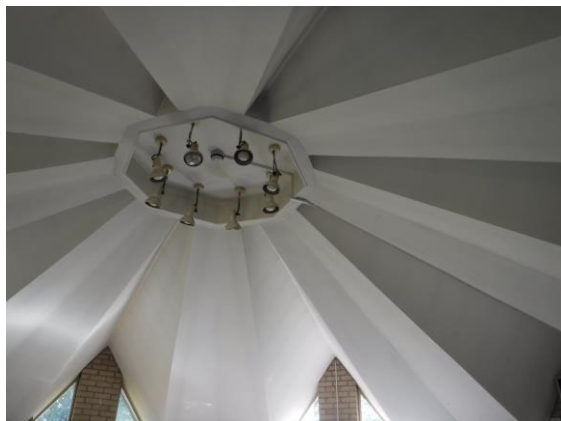
Comments: View of plasterboard ceiling. Non asbestos product.

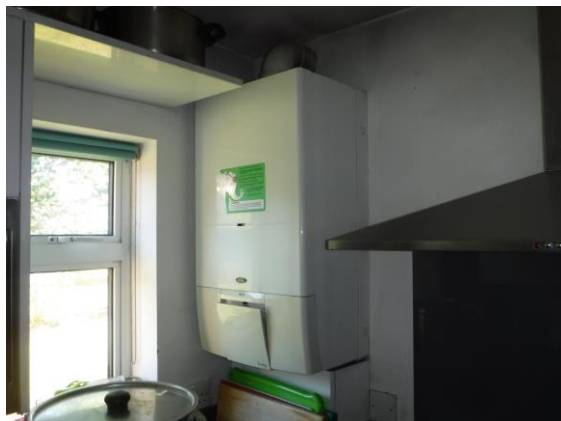
Comments: View of boiler unit. No asbestos detected.

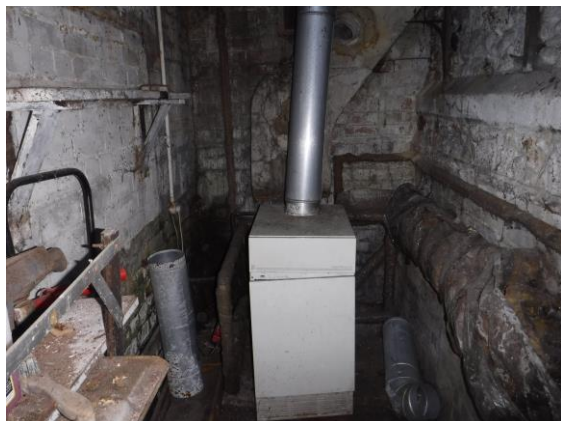
Comments: View of boiler unit. No asbestos detected.

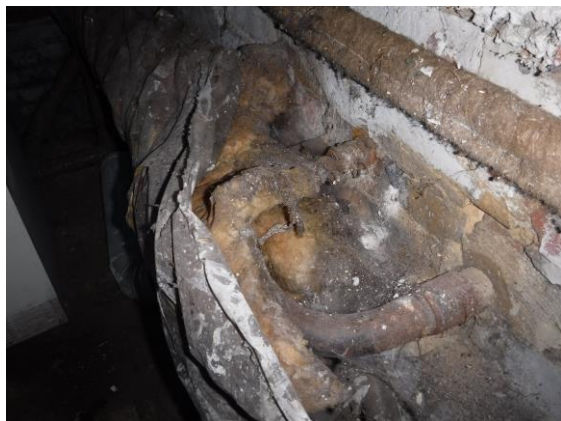
Comments: View of MMMF insulation to pipework. Non asbestos product.

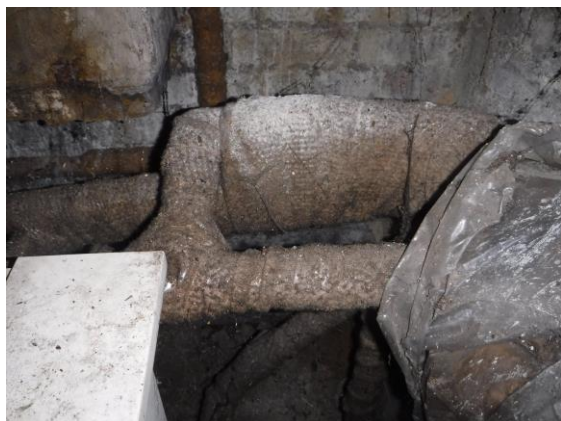
Comments: View of hessian wrap to pipework. Non asbestos product.

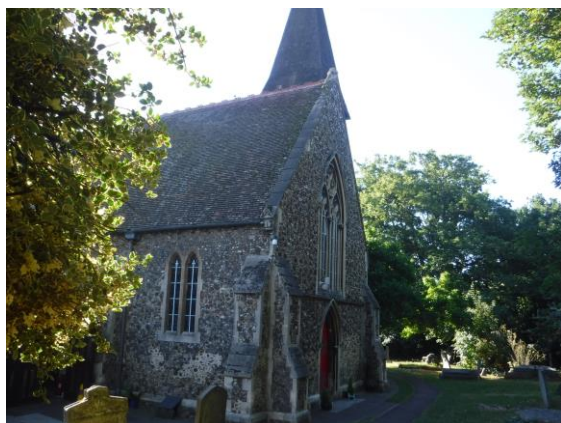
Comments: View at front elevation. No suspected asbestos containing materials identified to external areas.
