ASBESTOS MANAGEMENT SURVEY REPORT

**St Nicholas Church,
Church Street,
Great Wilbraham,
CB21 5JN**

Reference No: 2067M-B

Survey Date: 03rd March 2014

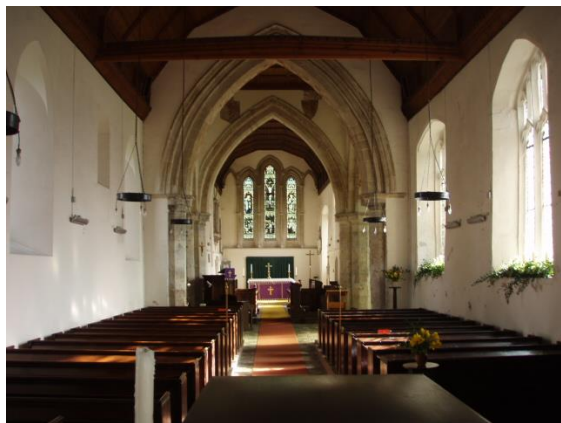
Page: One

Comments:- View at ground floor level.

Recommendations:- General photograph.

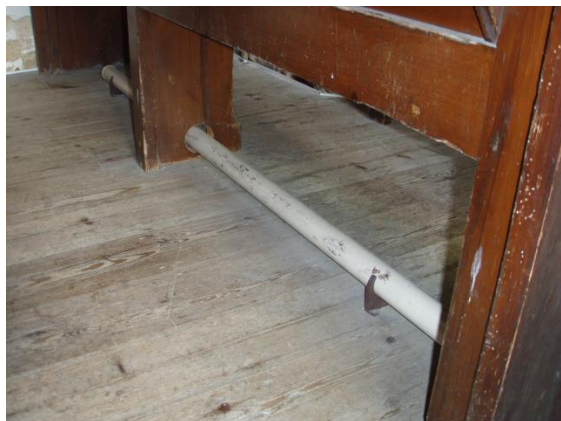
Page: Two

Comments:- View of No Access to internal of heater units. Live at the time of the survey.

Recommendations:- General photograph.

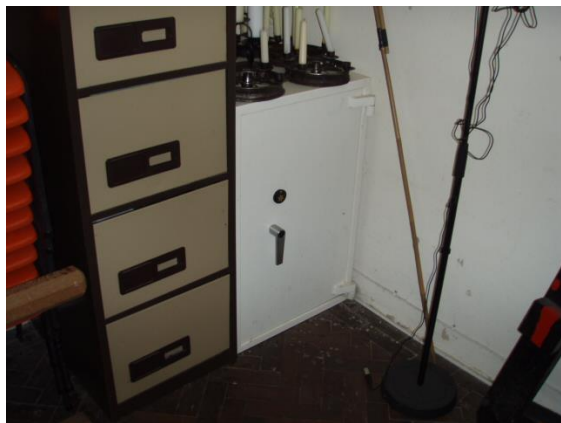
Page: Three

Insulating Board Internal Lining

Comments:- No Access within safe unit. Strongly presumed asbestos insulating board internal lining.

Good Condition

Recommendations:- Label and manage.

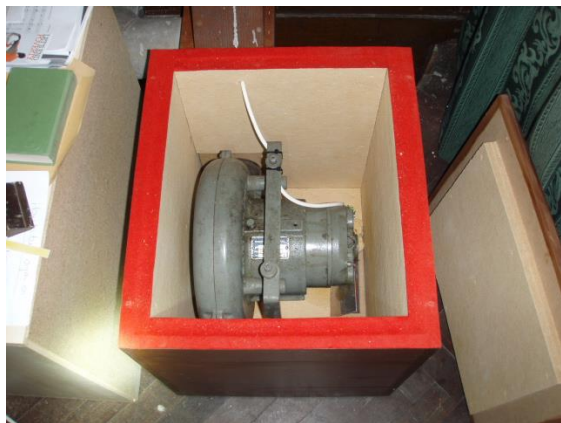
Comments:- View within organ motor box. No asbestos detected.

Recommendations:- General photograph.

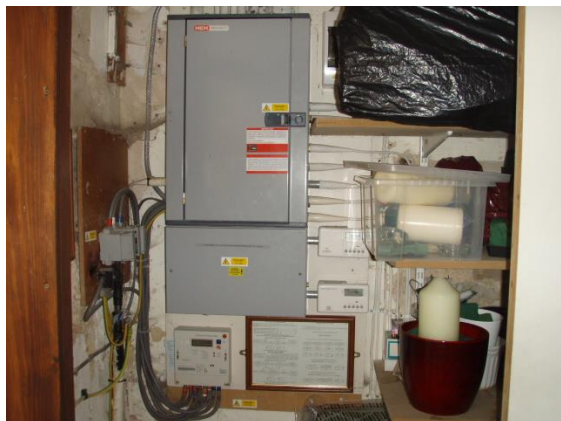
Comments:- View of modern electrical distribution board. Non asbestos product.

Recommendations:- General photograph.

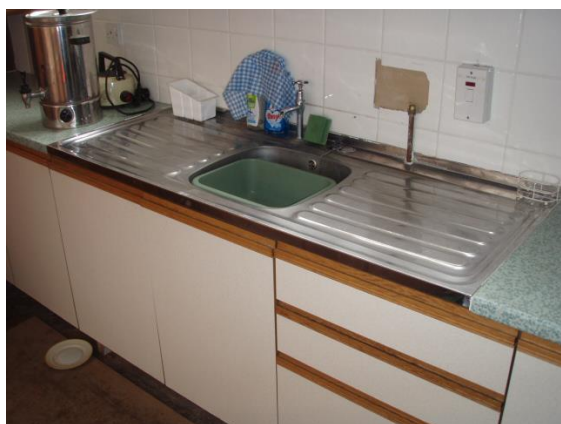
Ref.	Location	Description	Analytical Result
S001	Ground Floor, Kitchen	Sink Pad	NADIS

Comments:- Bitumen pad to underside of sink unit.

Recommendations:- No action required.

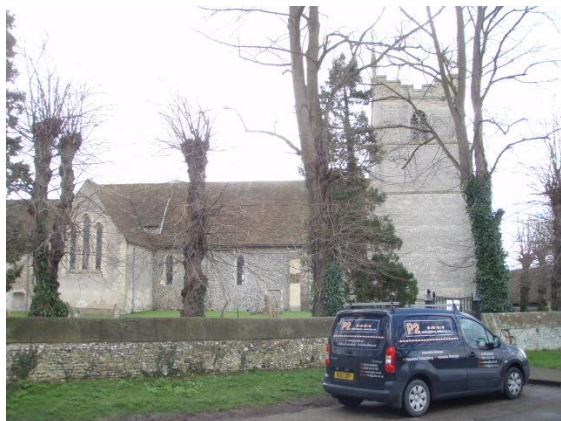
Comments:- View at rear elevation.

Recommendations:- General photograph.

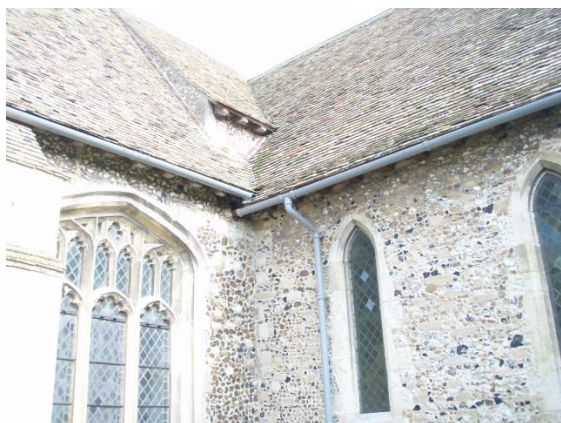
Comments:- View of metal rainwater goods. Non asbestos products.

Recommendations:- General photograph.
