Inspection /survey basic review

Rev 1 08/19

Summary

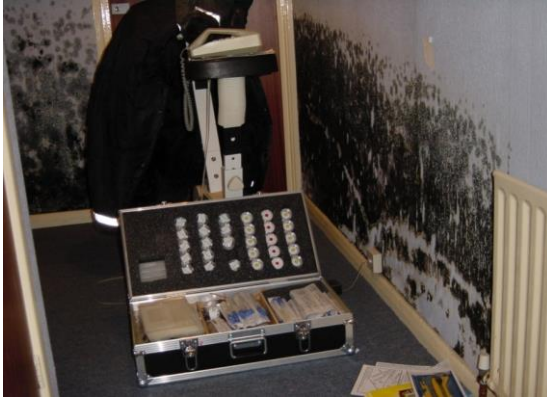
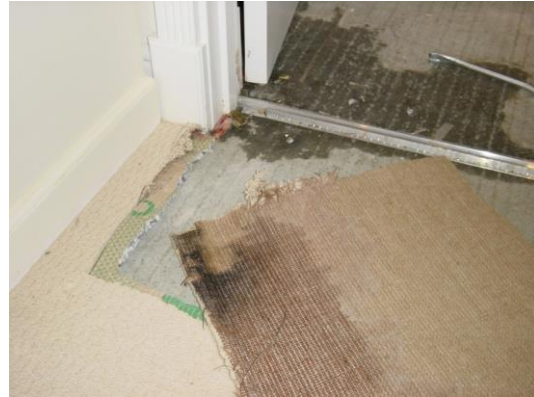
Investigation isn't as simple as it may seem. The property on the left incredibly wasn't as serious a health hazard as the photo on the right.

While the photo on the left shows heavy *Stachybotrys* growth, it wasn't producing mycotoxins. However, the right-hand picture shows the floor in my daughters brand new en suite bathroom. She developed chronic fatigue within 3 months of buying this new property and was diagnosed by University College Hospital London with advanced stages of Leukaemia. She got better and was back to normal within 3 weeks terminating exposure

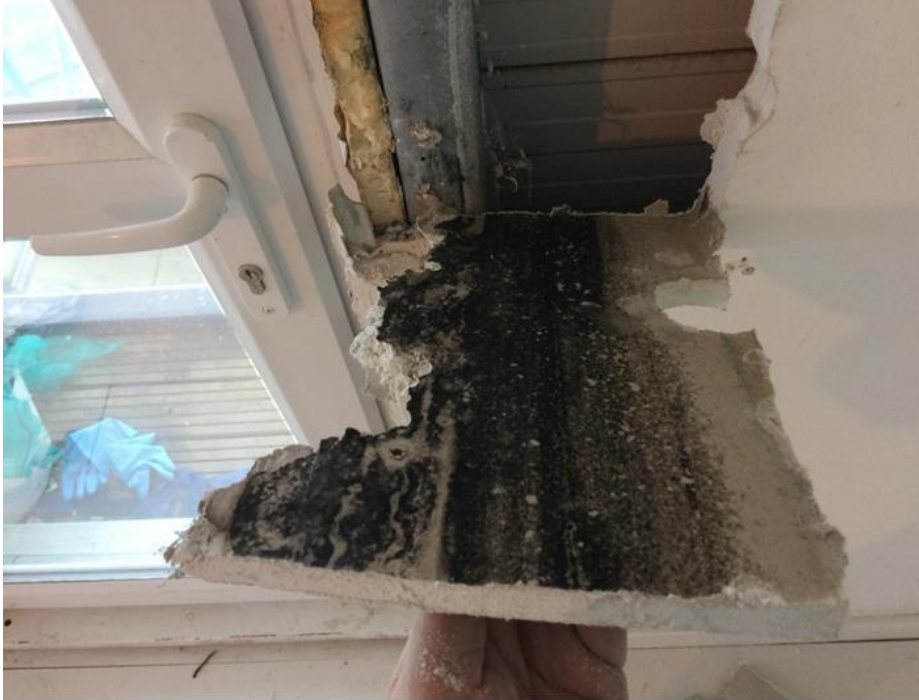
The landlord blamed "Lifestyle" (cooking peas without a lid on the saucepan) Our investigation quickly identified extremely toxic mould at very high levels. This resulted in the intrusive investigation which exposed the building construction/design defect below.

There was no insulation between the internal plasterboard and the outside metal facade and “Dew point” condensation and mould growth was inevitable. The family has been evacuated and the whole tower block now has a Class 1 hazard certification in force.

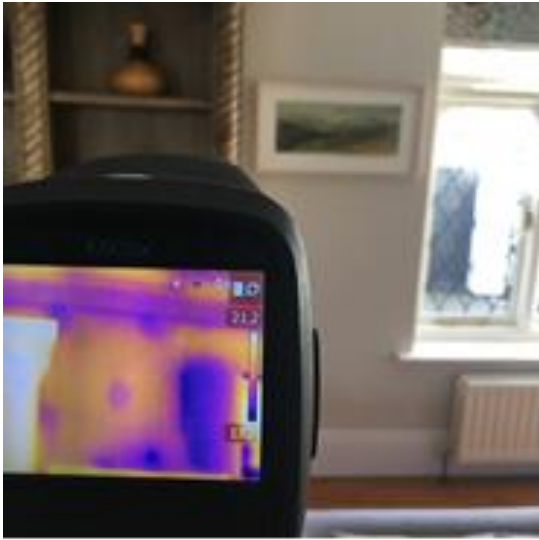
This property was in excellent order, but Infra-red survey coupled to moisture mapping showed serious hidden mould risks confirmed by sampling

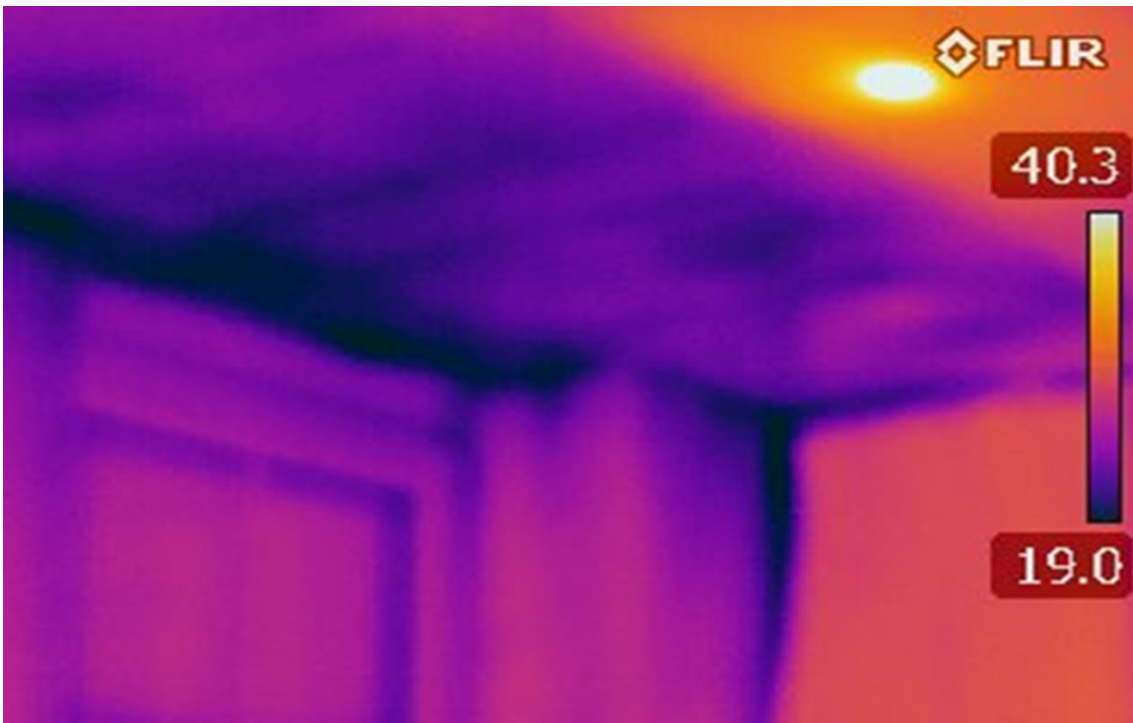
Free installation of loft insulation isn't always a good thing. In this case we identified that the free contractors hadn't installed the insulation properly and this resulted in the family developing CIRS from mould growth caused by the contractors incompetence.

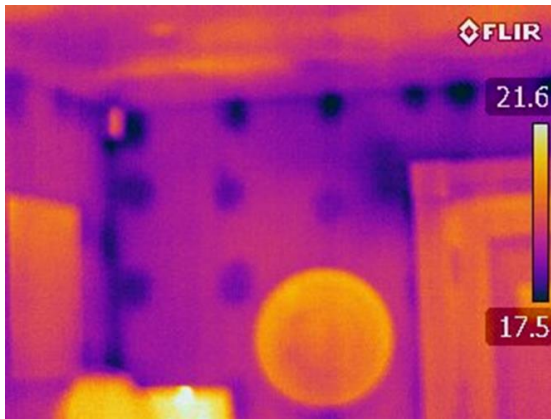
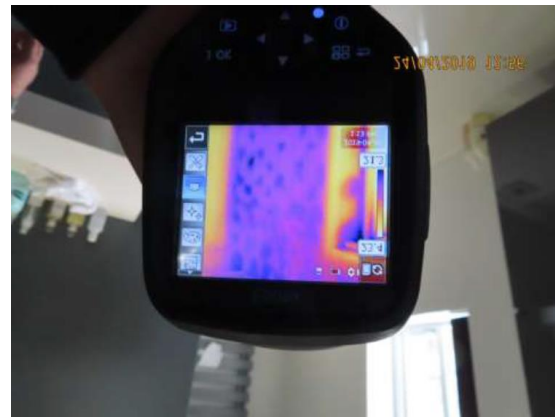
In this IR scan we identified Dot and dab construction which led to mould growth in the cavities which leached out to occupied spaces

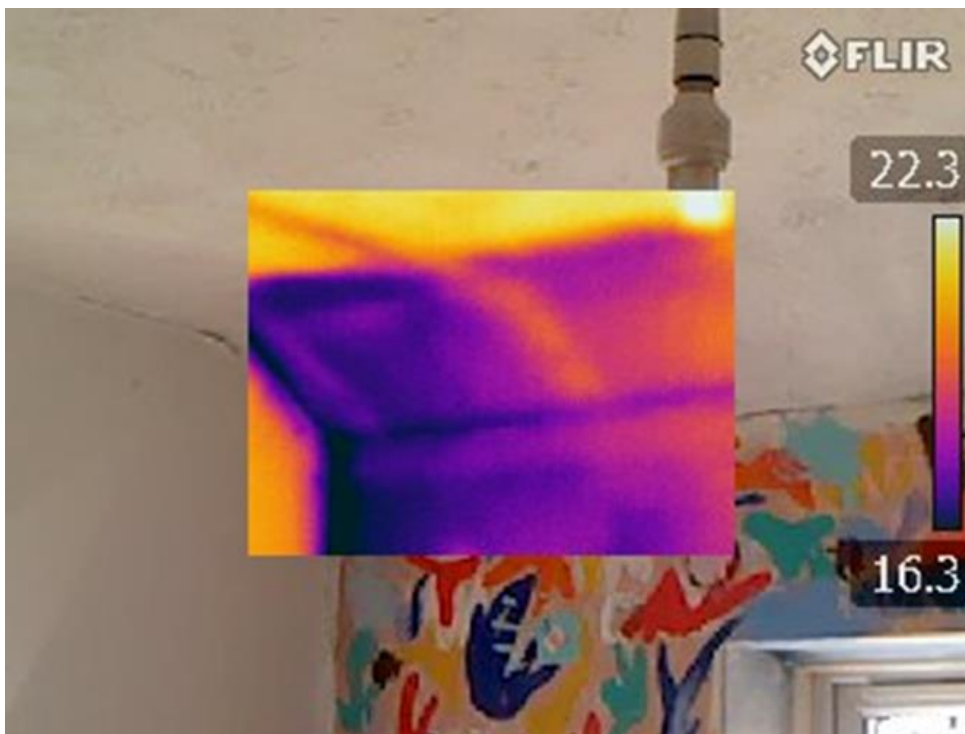
This shows the result of FREE Loft insulation which resulted in dew Point condensation and mould growth leaking into the bedroom. The insulation wasn't homogenous and led to dew point condensation and resultant mould growth

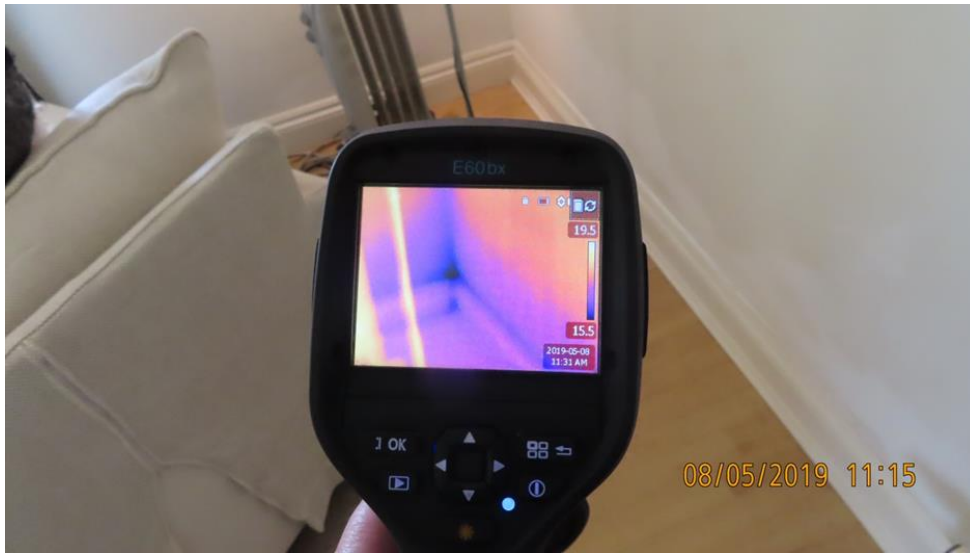
Rising damp issues caused by DIY actions

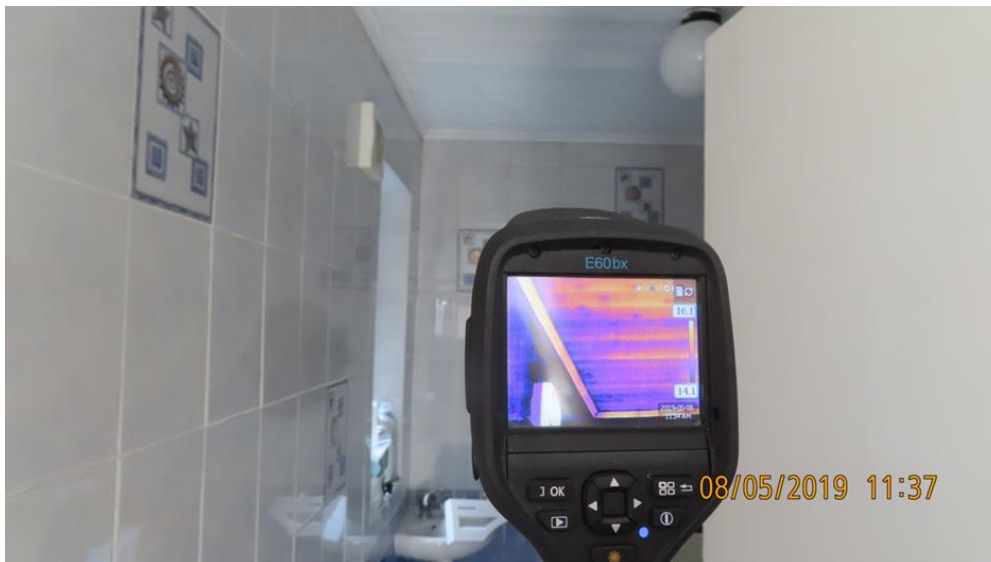
This bathroom has poor ceiling insulation and dew point condensation within ceiling cavity causing mould growth and poor health for occupants

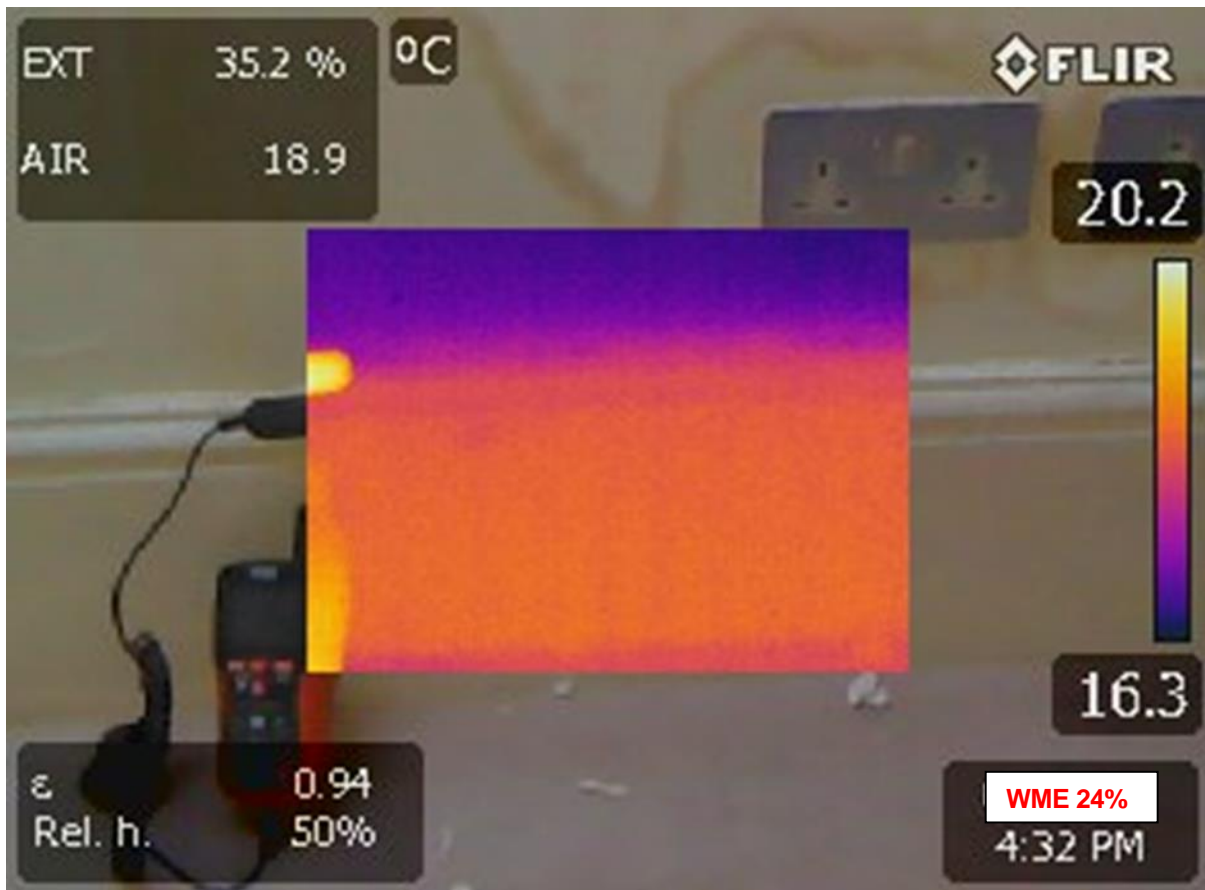
The Infra-Red camera also provides temperature, humidity and moisture content. This photo shows a serious damp issue in the wall and behind skirting board

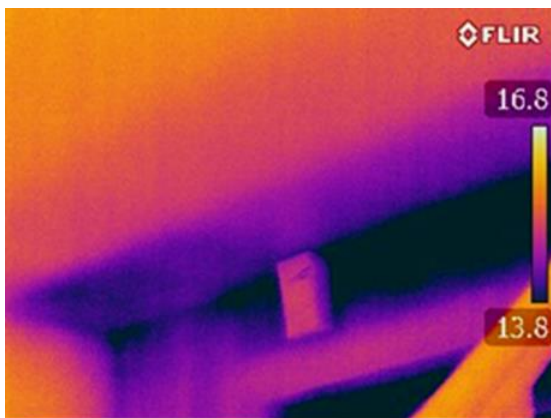
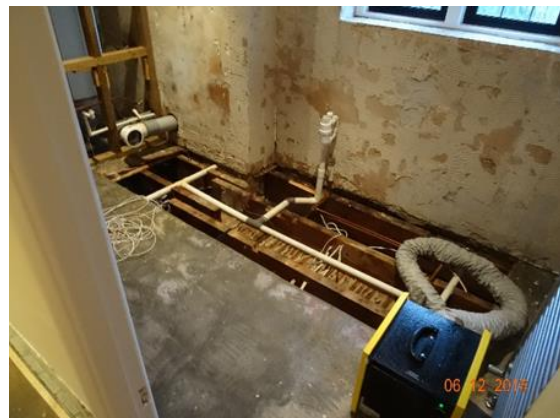
Infra red scan from hall indicated possible leaks from bathroom above. This was confirmed by other testing and resulted in strip out to facilitate remediation and decontamination

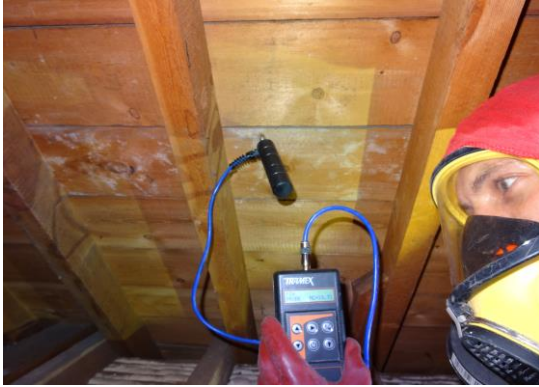
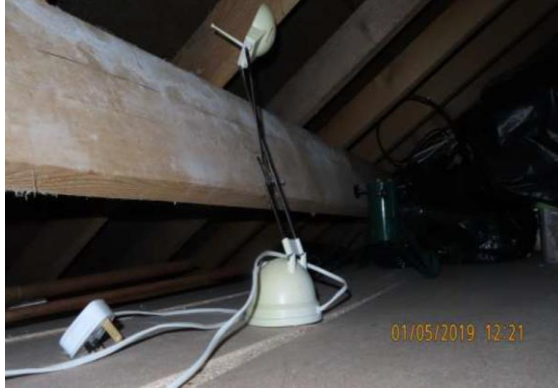
Moisture evaporating from basement ends up in loft and condenses on cooler surfaces and here we see mould growth

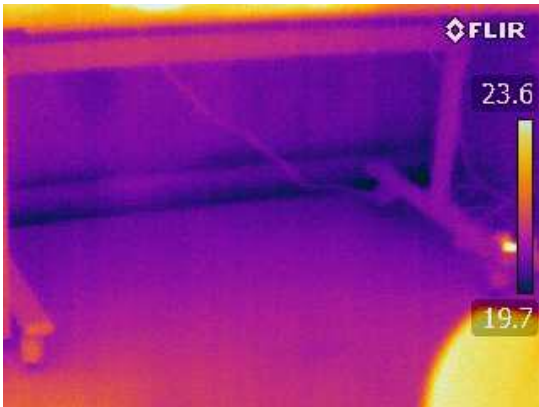
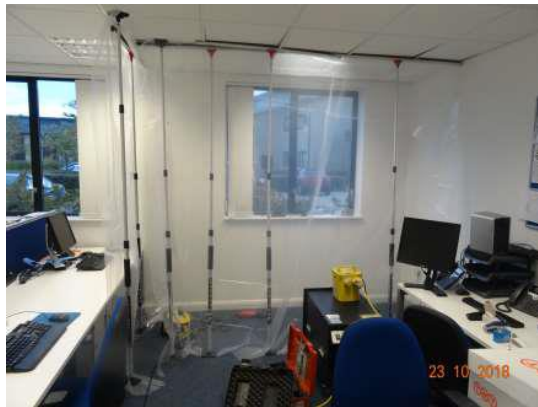
Following health complaints, this Infra red scan of a “New Build” identified something wrong with the construction at the low level of the wall (under the desk). Critical barriers with negative pressure was installed to enable intrusive investigation without releasing contaminants. Investigation identified construction defect, water damage and potentially toxic mould.

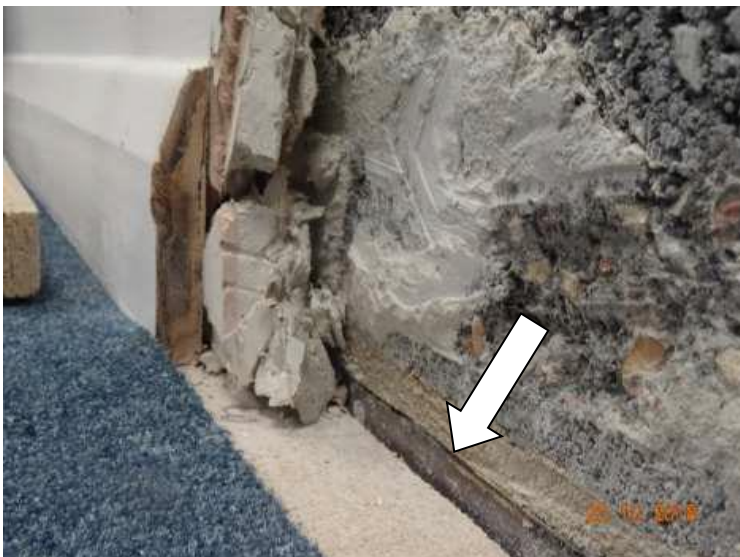
After opening the wall, we found the Damp Proof Course (DPC) had been installed above the floor. This led to moisture being absorbed into the floor, and wall through capillary bridging of dot and dab

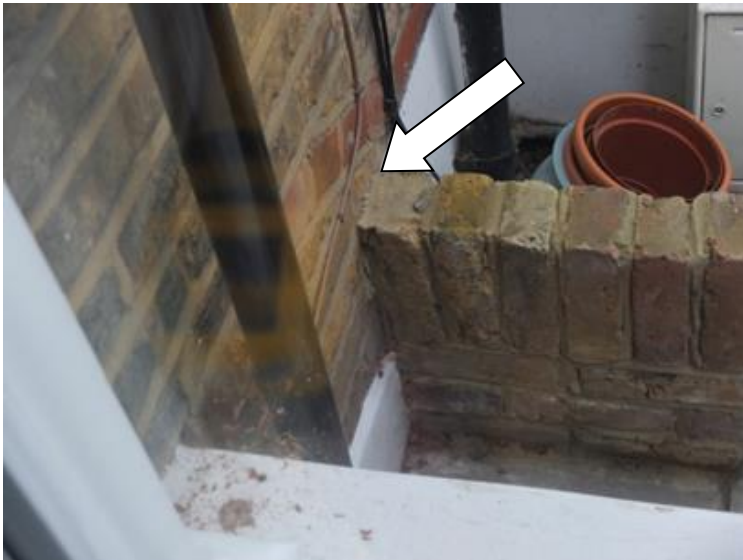
Simple construction defect where party brick wall has bridged DPC and capillary action caused internal damp & mould growth

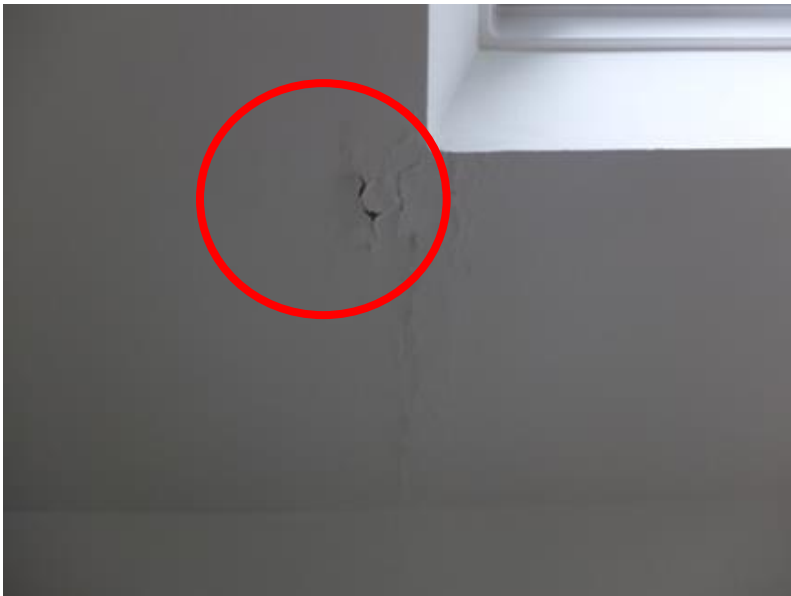
A minor leak from poor window installation led to major mould growth in ceiling cavity which leached out through downlighters etc

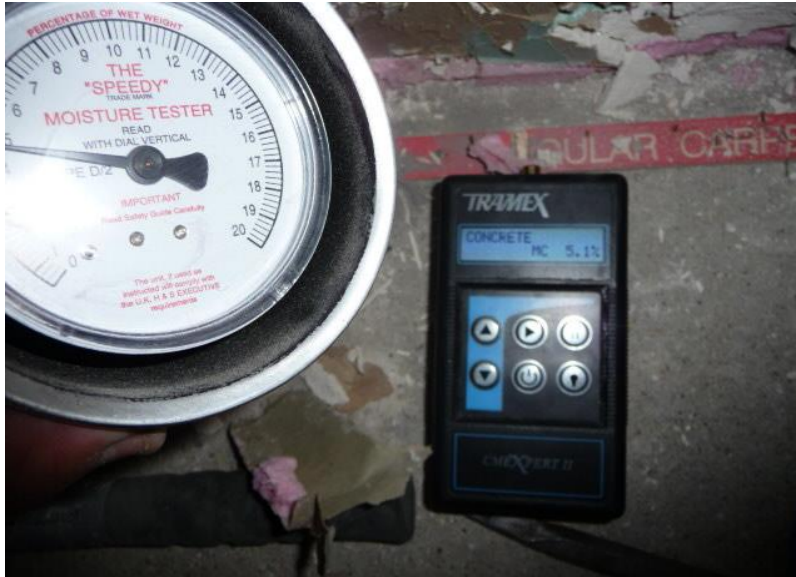
Sometimes the floor is wet from previous water damage or poor construction. The wet floor can cause failure of laminate floors, vinyl and of course carpet and cause bio contamination and or chemical exposure

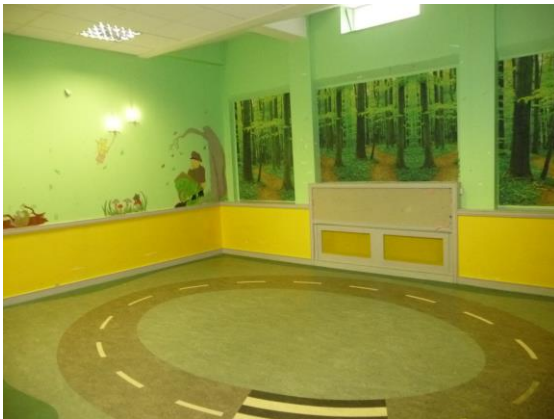
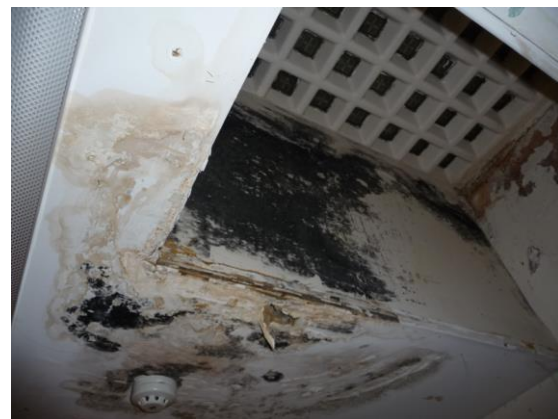
Mums at this basement play school knew children got sick during the week while attending the school. Inspection caused concern of ceiling and intrusive inspection revealed the true condition above the false ceiling. Air analysis showed extremely high levels of several toxic moulds present and the leaking pavement lights confirmed just one of the sources.

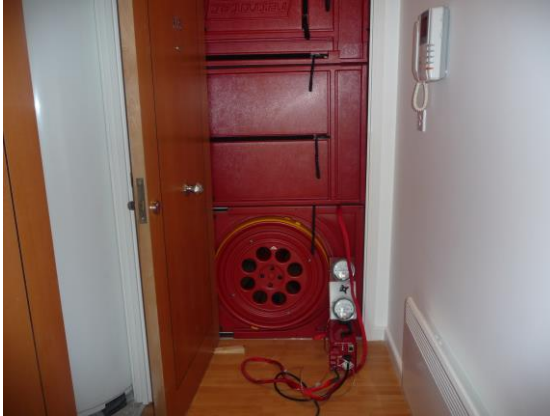
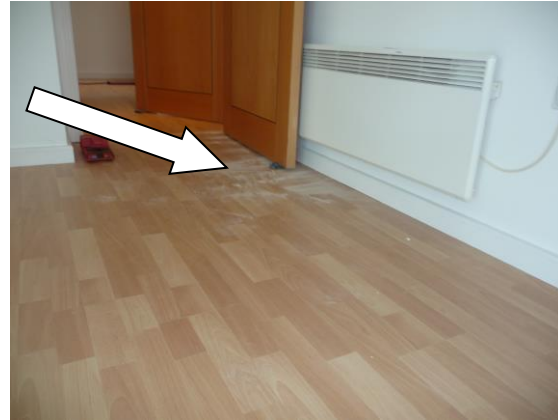
Sometimes contamination is within walls and in this “New Build” we were allowed to install a blower door to create a negative pressure in the home. This caused contamination to be revealed as it was pulled from wall cavities under the skirting.

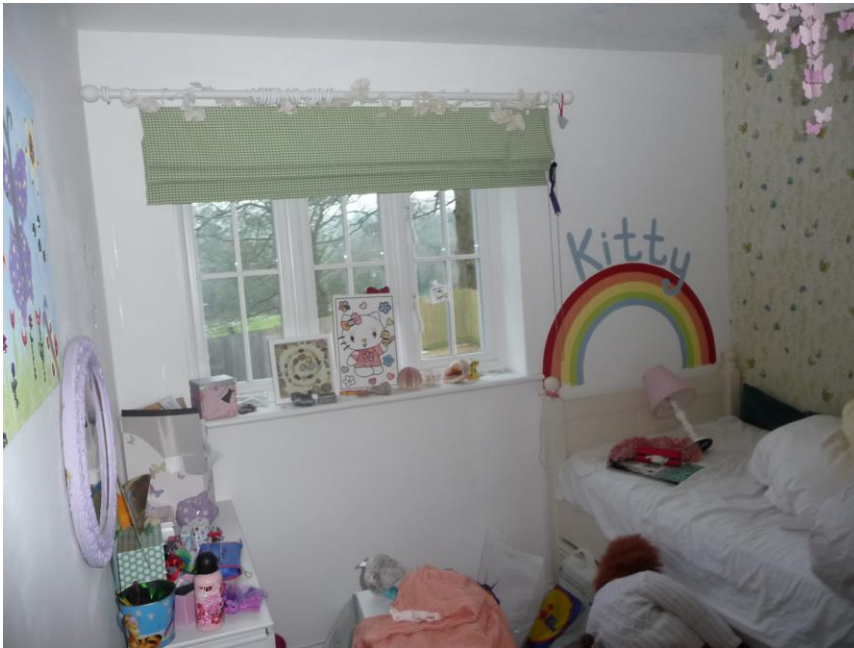
This bedroom was beautifully decorated, but the little girl had severe CIRS illness which developed within 2 years of moving in. Moisture mapping and IR dictated high risk and the following lab analysis gave great concern

Genus	Katie bedroom m ³	Ambient m ³
Penicillium/Aspergillus	180,000	360
Chaetomium	1900	BDL
Stachybotrys	14,500	BDL

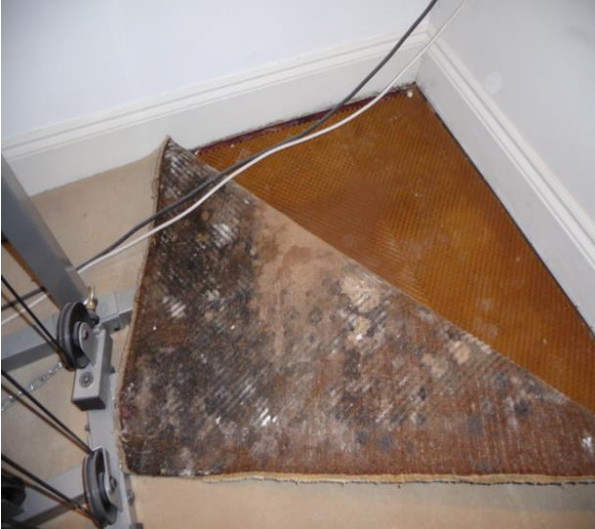
This new build £5million home had a gymnasium in the lower ground. The family were very sick especially after training .

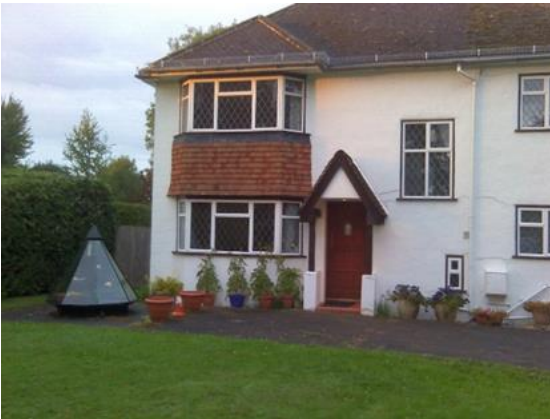
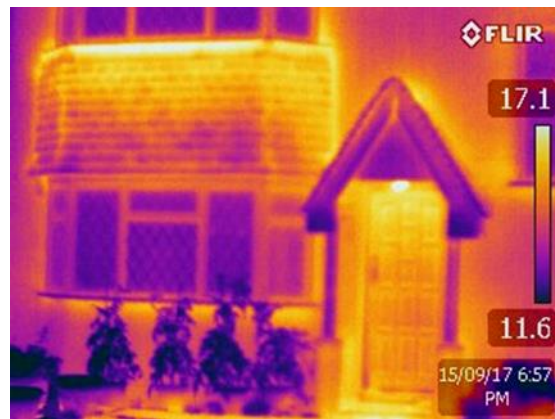
Part of our basic inspection is Thermal imaging and here we see a house with major insulation issues which resulted in dew point condensation and mould growth

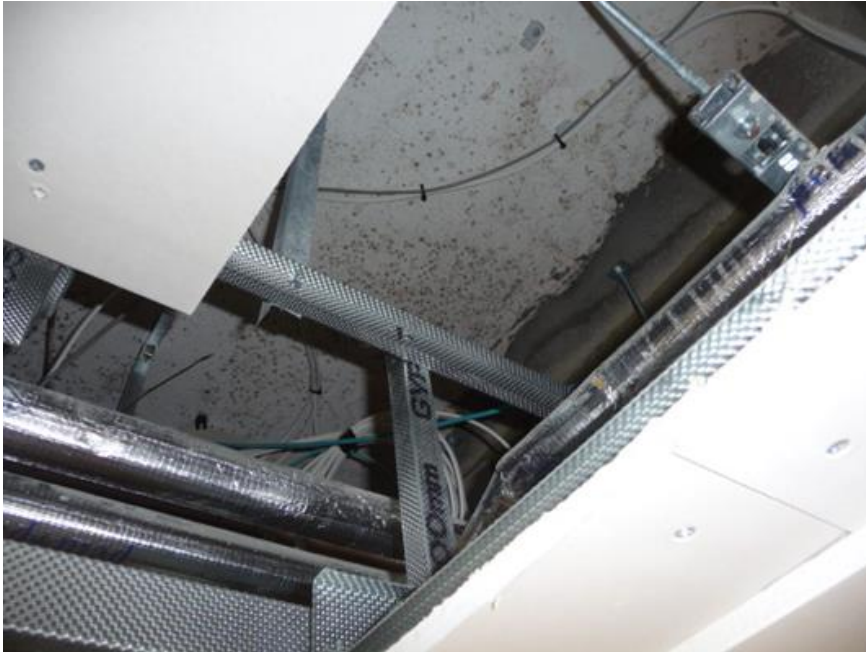
This is the ceiling of a £3 million property conversion flat. The occupants identified building related illness within 6 months of moving in. Our investigation found a suspended ceiling had been overlaid against an historic mouldy ceiling and bio toxins were leaking into the occupied spaces.
