Your survey and valuation report

XXXXXXX, XXXXXXX, XXXXXXX, United Kingdom, XXXXXXX

23/08/2022

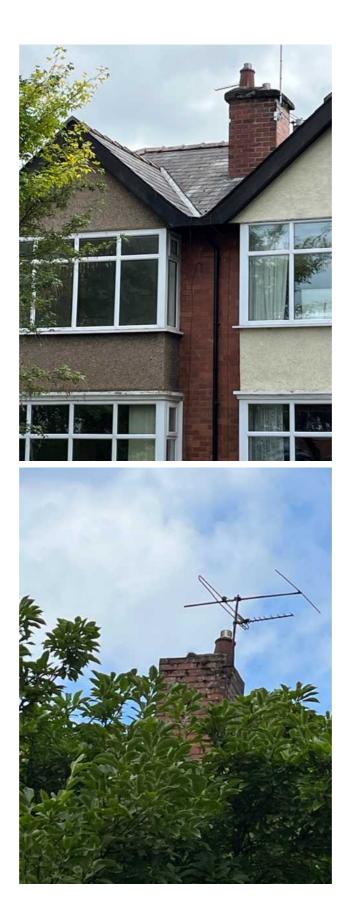
Following our inspection taken at ground level we noted minor pointing is now needed to the rear stack along with checking the cement flaunching on the front stack to ensure that it is securely fixed in position.

With regard to the flues we cannot confirm if they have been lined and therefore if you are intending to re-use any of the fires these will need to be tested.

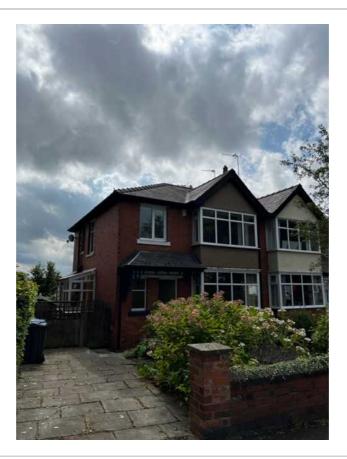
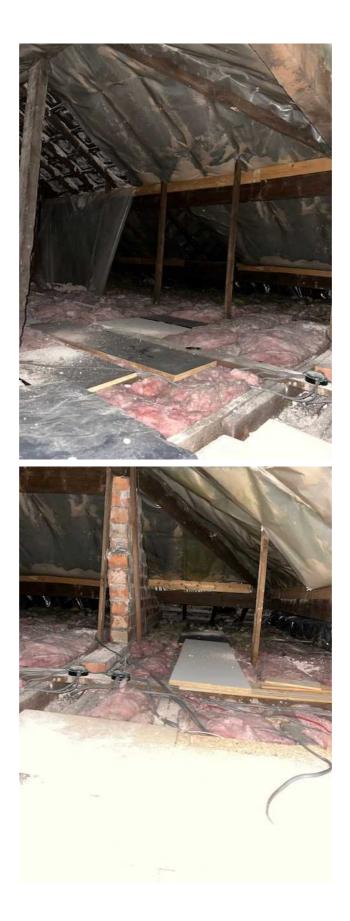
D2 Roof coverings

The main roof is pitched and covered with natural slate which is not laid over any form of felt lining. Beneath the roof coverings plastic sheeting has been fitted to the underside of the rafters in an attempt to reduce dusting and the old lime torching falling onto the insulation.

Due to the age of the roof coverings the nails used to secure the slates in position will have suffered from corrosion and therefore there is now greater risk of the slates dislodging and slipping down the roof.

In addition all of the lead work fitted in each of the valleys is likely to be original and therefore will have deteriorated.

On the front slope there is a short section of shared box gutter, which appears to be lined with lead, complete with a narrow spitter and again this will need to be maintained to prevent any risk of blockages which in turn will cause internal water ingress.

The roof does have good alignment across each of the slopes and therefore all of the main roof timbers are adequately sized and supported but because there is no felt beneath ongoing maintenance is now needed to replaced and re-fix any slipped slates and ultimately consideration will need to be given towards completely stripping the roof and re-laying the slates over a new breathable felt lining together with pre-treated battens.

Finally on the rear of the property the flat roof above the bay window is covered using mineral felt which appears to be free from damage.

The time when this will be needed is very much dependent upon how it is maintained in the interim but as a guide we would suggest within the next 5-10 years and based at today's prices the cost is likely to be in the region of £5,000-6,000.

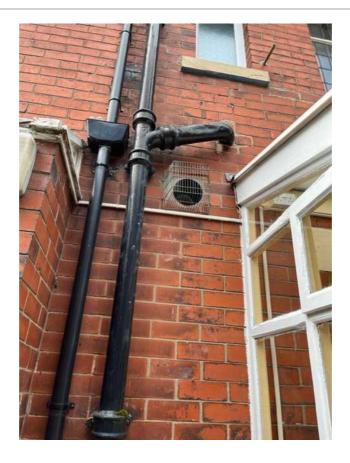
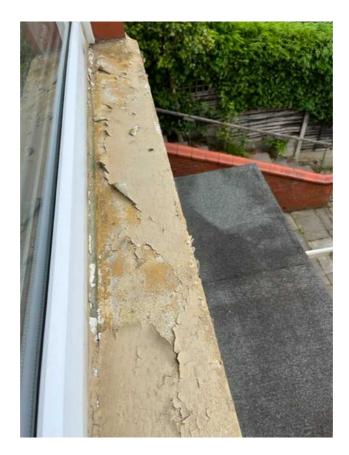
On the front bay window pebble dash render has been fitted and this is now suffering from general deterioration and again repairs will soon be needed.

All of the stone work forming the cills is now in need of scraping down and redecorating.

Numerous air bricks have been introduced, particularly to the front elevation, the purpose of which is to provide ventilation to the sub floor areas, including the basement.

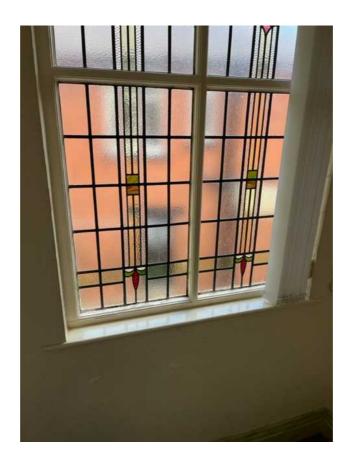
D5 Windows

The windows throughout are mainly double glazed uPVC and we would suggest are in excess of 15 years old and therefore no longer under guarantee.

There are two original timber frames, complete with leaded lights, on the stairs and hallway which now have several cracked panes.

A sample of windows were tested and found to have suffered wear and tear to the handles and hinges.

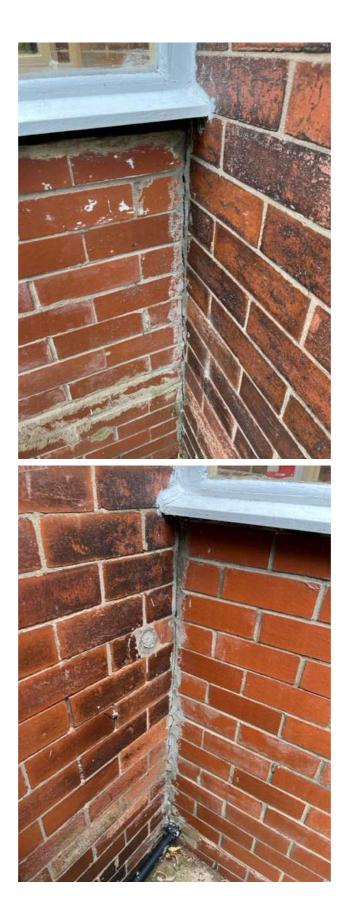
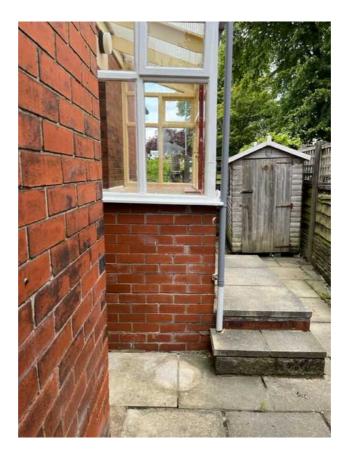
D6 Outside doors (including patio doors)

The external doors are again uPVC and these appear to be in excess of 10 years old and therefore no longer under guarantee.

The front door has a missing rain drip and each of the doors when tested were found to have suffered wear and tear to the handles and locks.

The side porch is designed with a sloping translucent roof together with suspended floor, which when tested was found to suffer from deflection when walked on, however because it is overlaid with laminate further investigation would be needed to identify whether the joists themselves are in need of replacement.

Following our external inspection of the porch we noted the structure has suffered from past settlement, which has resulted in a tapering gap where it joins onto the side elevation together with sloping cills and brickwork.

The cause of this is most likely due to the foundations being inadequate and therefore there is potential for further movement to occur.

All of the wooden window frames are now suffering from wet rot within the bottom sections to the extent replacement will soon be needed.

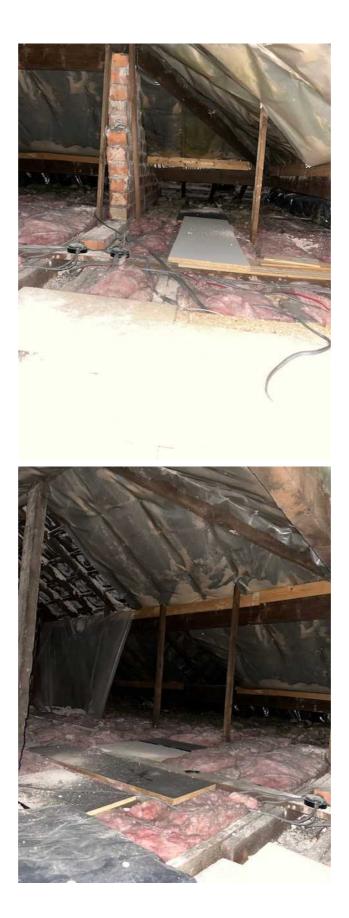
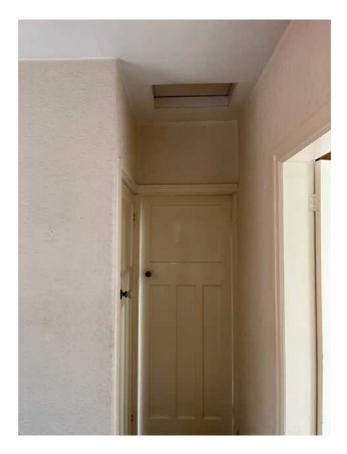
As previously reported the roof is not protected by any form of felt lining and all of the lime torching is now missing and resting on the ceiling.

The separating fire wall, where visible, has been fully built up and generally the level of ventilation within the roof space is adequate.

Finally old staining was recorded along the top edges of the roof timbers and this is as a result of past water ingress and in order to prevent any risk of wet rot the roof will need to be regularly maintained to ensure that all slates and pointing are securely in place.

There is currently a 50mm layer of insulation laid between the ceiling joists, which we recommend is increased to 300mm to further reduce heat loss.

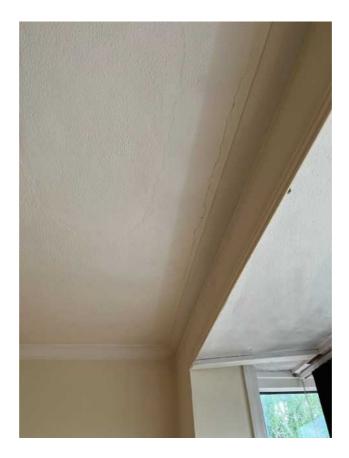
E2 Ceilings

The ceilings throughout are all original and consist of lath and plaster and in some rooms cracks have now formed, for example on the rear lounge ceiling and along the bay, therefore you should expect some repairs as part of future maintenance.

Finally the ceiling in the small bedroom has a textured coating. Such coatings can contain small amounts of asbestos fibres and if disturbed, it could be a safety hazard. If the ceiling needs redecorating or repairing, you should where possible avoid any sanding or drilling together with wearing suitable protective clothing such as face masks and damping down the material. See Section I Risks.

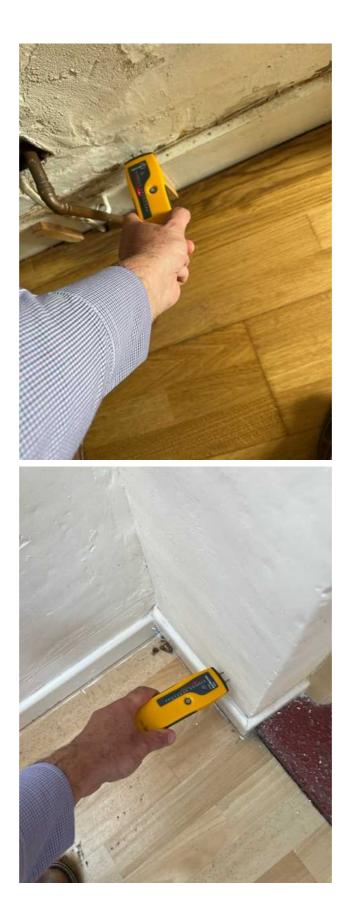
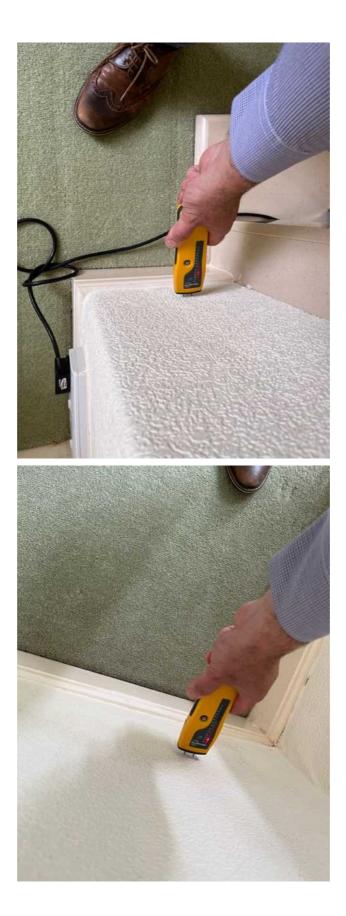
E3 Walls and partitions

Following our inspection in each of the rooms we did record minor distortion above some of the door heads, together with cracked plaster, for example around the lounge door opening. The cause of this is historic settlement within the internal and external doors but this all appears to be long standing and therefore the risk of any further movement is minimal.

Above normal readings were recorded in several areas including under the stairs, within the front chimney breast and front left hand corner of the living room. In the first instance we would recommend monitoring the levels of dampness over a period of 6 months and in the event the problem becomes worse consideration will need to be given towards the installation of a partial new damp proof course.

Please note all of the walls in the rear living room have been panelled and therefore testing for dampness could not be carried out.

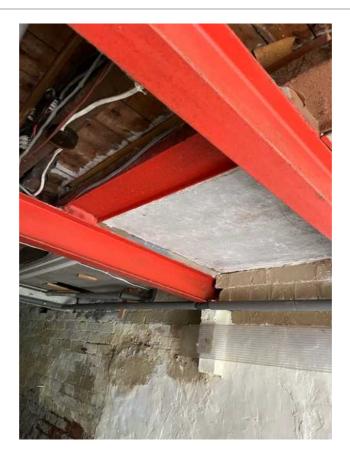
E4 Floors

The floors throughout are all suspended timber and we suggest consist of the original joists and floorboards and on the ground floor the timbers were exposed and available for inspection via the basement.

We noted within the basement several sections of steel have been introduced below the kitchen floor and in particular around the position of the stone slab adjacent to the external door.

Below the slab is a piece of boarding which possibly contains asbestos and therefore this should not be removed without taking the necessary precautions. See Section I - Risks.

Following a toe and heel test in each of the rooms the floors were generally found to be sound together with no signs of woodworm where inspected. Please note in some rooms laminate flooring has been laid which can conceal hidden defects.

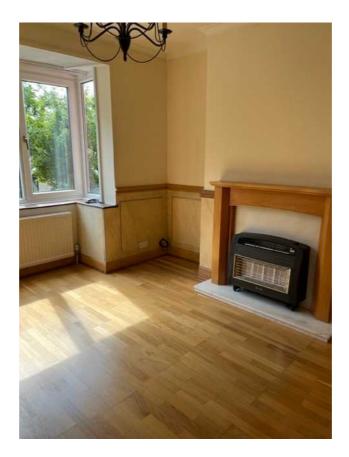
E5 Fireplaces, chimney breasts and flues

Currently there is only one flue in use which is in the rear sitting room where a gas fire is installed.

This fire was not tested and prior to re-use we recommend it is inspected and serviced by a Gas Safe registered heating engineer. See Section I - Risks

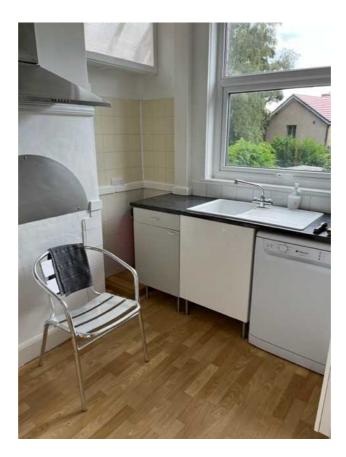
E6 Built-in fittings (built-in kitchen and other fittings, not including appliances)

With regard to the appliances these were not fully tested and for more information you should contact the Seller.

We recommend consideration is given toward the replacement of the units which is likely to include the need for re-plastering.

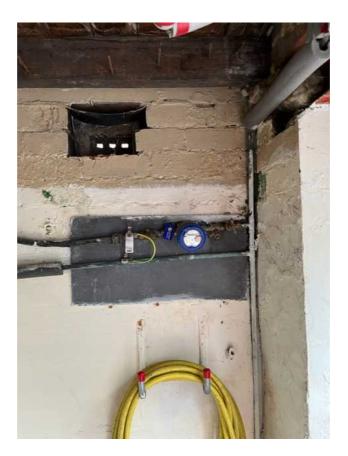
F3 Water

It would appear that he incoming water main has been replaced with plastic.

The water pressure was tested at each of the outlets and found to be good.

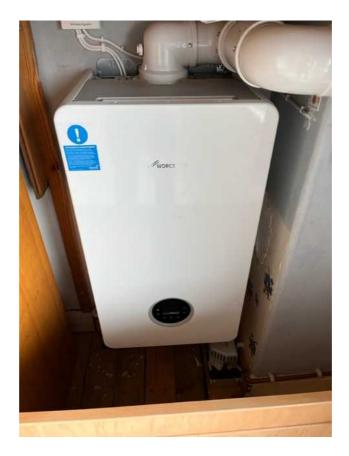
F4 Heating

The boiler connects to older style pressed steel single panel radiators fitted in each of the rooms through 15mm copper pipework and the heating is controlled by a programmer and room thermostat.

Due to the age of the radiators and the fact some are possibly undersized, for example in the bedrooms, we strongly recommend you arrange for the entire installations to be inspected and tested by a suitably qualified heating engineer prior to purchase.
