## COCKERMOUTH RECOVERY FAILURES and Deja vu 2009

Three weeks after the town of Cockermouth was flooded I undertook this audit of flood restoration progress. I had intended to spend a couple of days reviewing the progress in restoration competence since the floods of Hull, Doncaster, and Sheffield of 2007 where homes took months to years to restore. In less than two hours I realised there was no improvement from my inspections of 2007 or indeed my flood audits of Carlisle 2005 and even going back to Lewes in 2000.

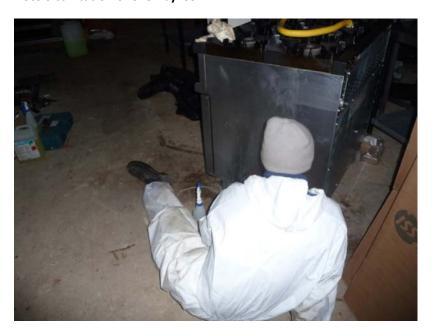
Photo 10 Sanitation of deep fat fryer by ISS

The pump up pot is for spraying a sanitising chemical onto the wall and is useless because if it was any good the man spraying it would be wearing, rubber not cloth gloves, a respirator and goggles, equally he wouldn't be doing it over the head of his technician colleague who is wiping down the black paintwork with a towel. This detailed decontamination is perhaps a little premature as the whole pub and basement has yet to be dried and restored. Perhaps the whole pub and basement should have been steam cleaned?

Possibly a waste of time and money?
