INDEPENDENT AUDIT (2)

INSURANCE INDUSTRY RESPONSE to FLOOD AFFECTED BUILDINGS in CARLISLE 2005

Apathy or Ignorance?

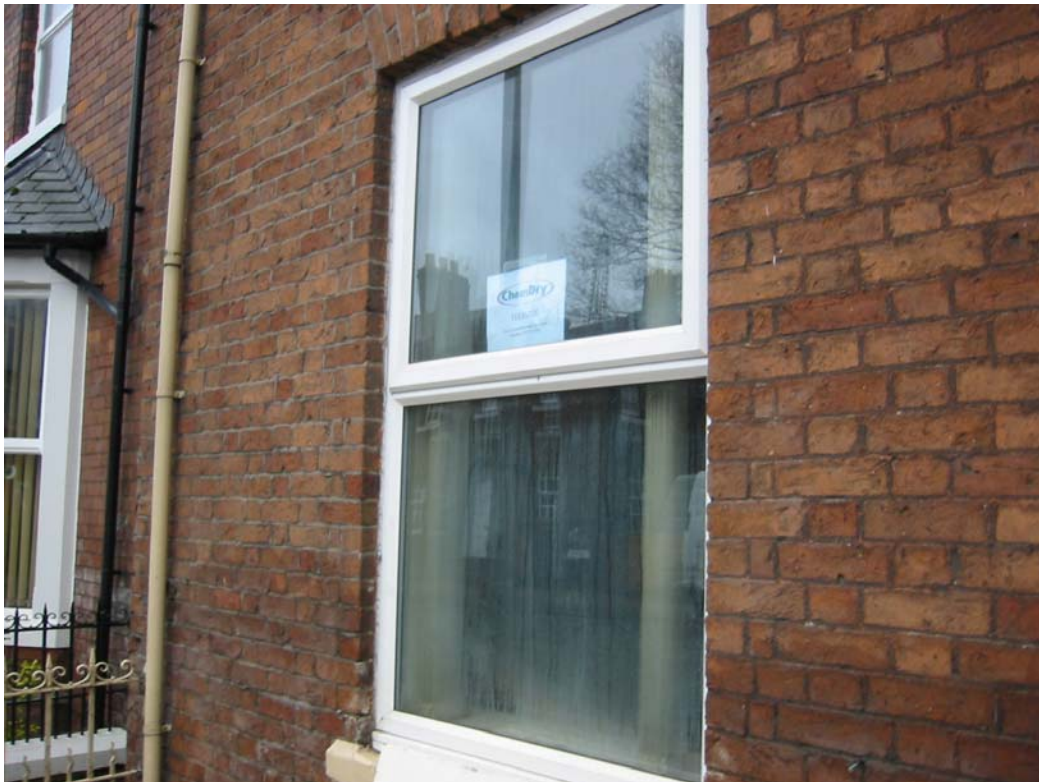
Raining Inside,

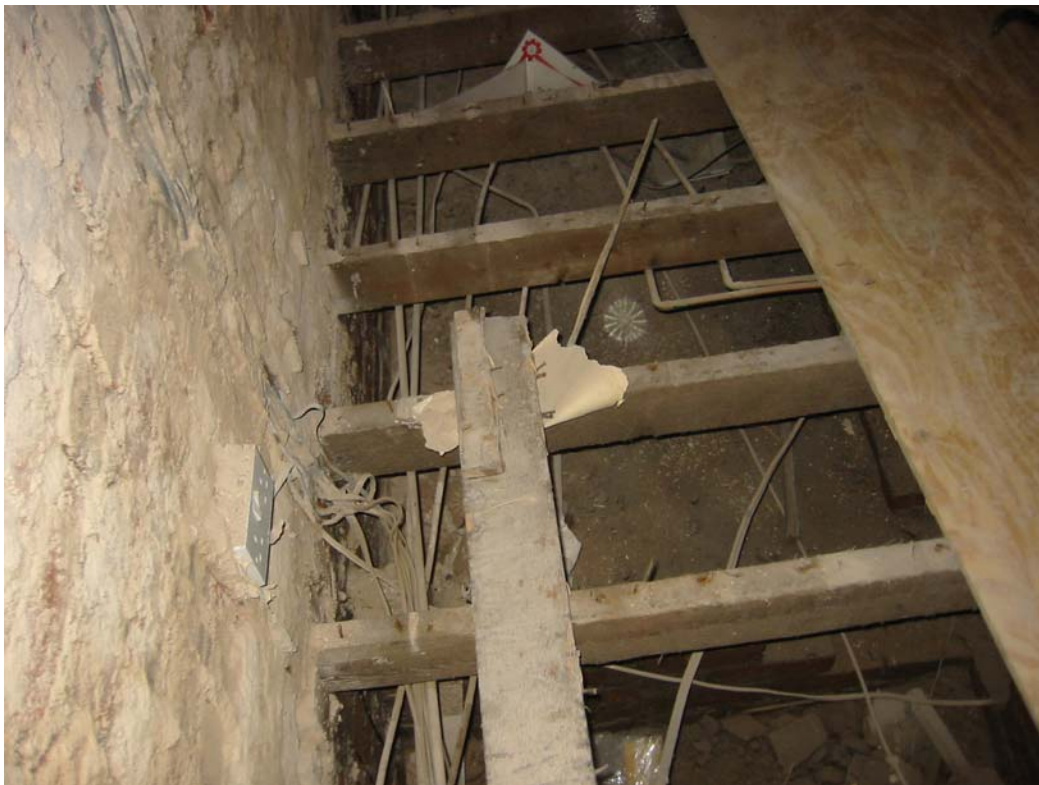
If all wet materials and some that are dry are cut out, drying costs can be reduced to zero. Building costs may escalate but is free drying too good to miss? Note the paper under the wet floor board and wet joist, the dust on top of the power socket! Both buildings were DRY!

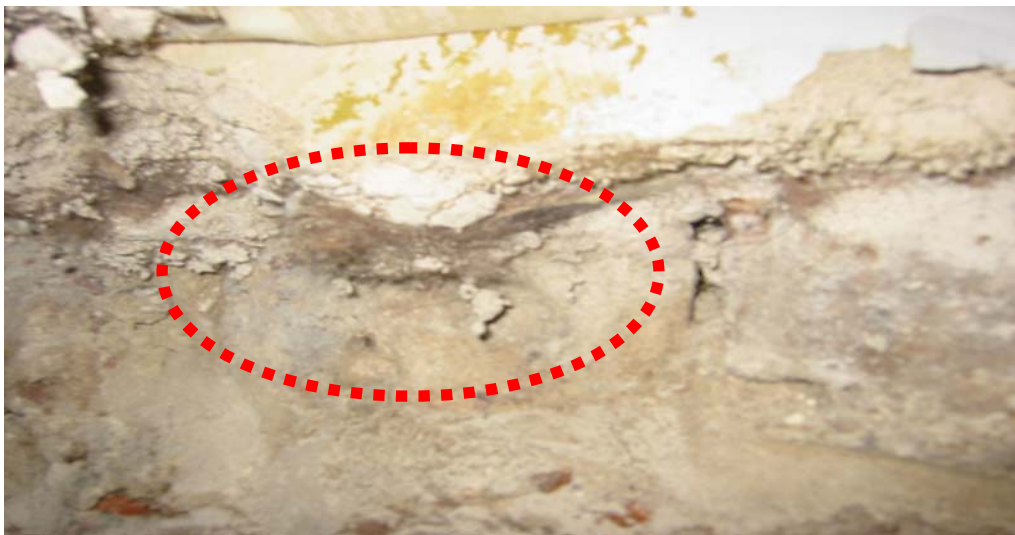
Case study 1 Revisited

This is a sad statement of the industry. In the previous audit document I mentioned this claim. The surveyor said the building was wet and told the hoteliers they had to move out while their home and business was gutted. I surveyed the property and found it to be dry. I showed the insured who was surprised to say the least. I called the Insurance Company and told them a mistake had been made, so confident were they in their surveyor they ignored my warning. I offered to meet their loss adjuster on site and prove but they declined. On Wednesday 9th Feb the builders arrived to gut out. I saw the policy holder who was clearly concerned. I asked if he had spoken with insurers and he said yes, they had told him to accept their advice or he would not have redress or their support.

The builders had to steam off the wallpaper as it was dry, and you can see the moisture runs on the wall.
